# **JSE JOHNSON STRUCTURAL ENGINEERING, INC.**

101 Huntoon Memorial Highway (Rt. 56), Rochdale, MA 01542 (508) 892-4884 Fax (508) 892-0477

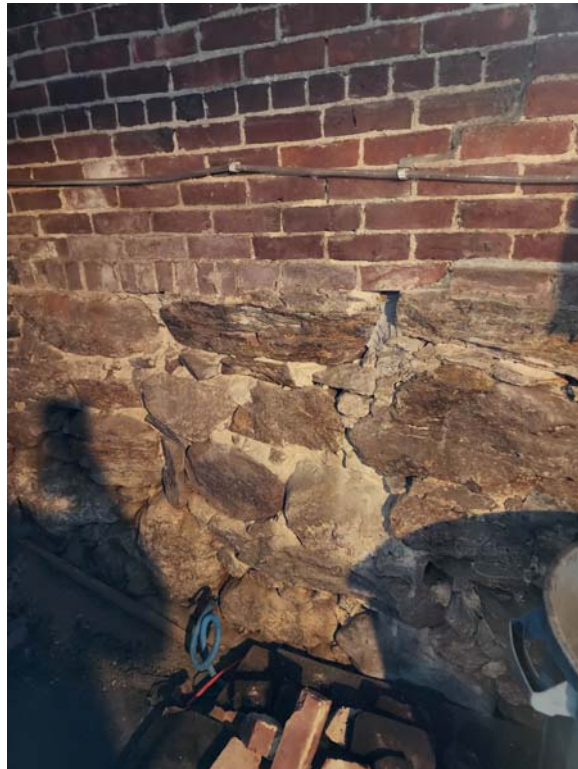
Photograph #14 (Town Hall)  
– Deteriorated Masonry/Field Stone Mortar Joints

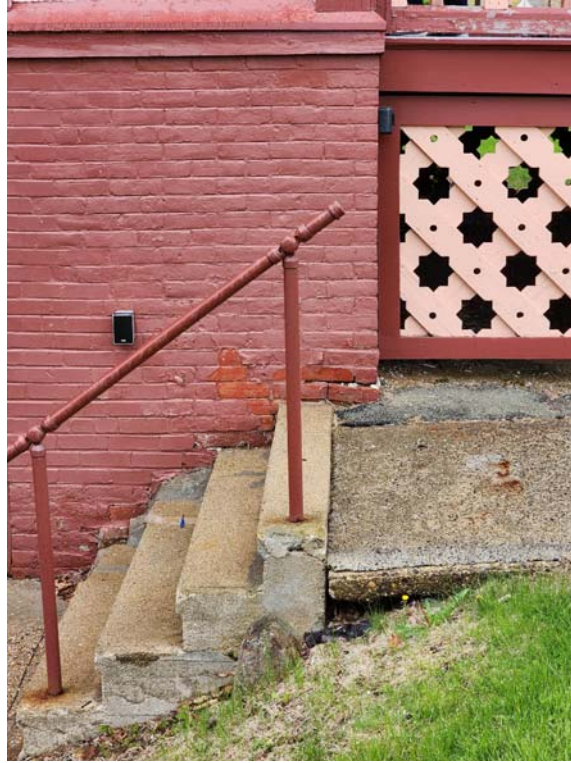
Photograph #21 (Town Hall)  
– Damaged Exterior Masonry

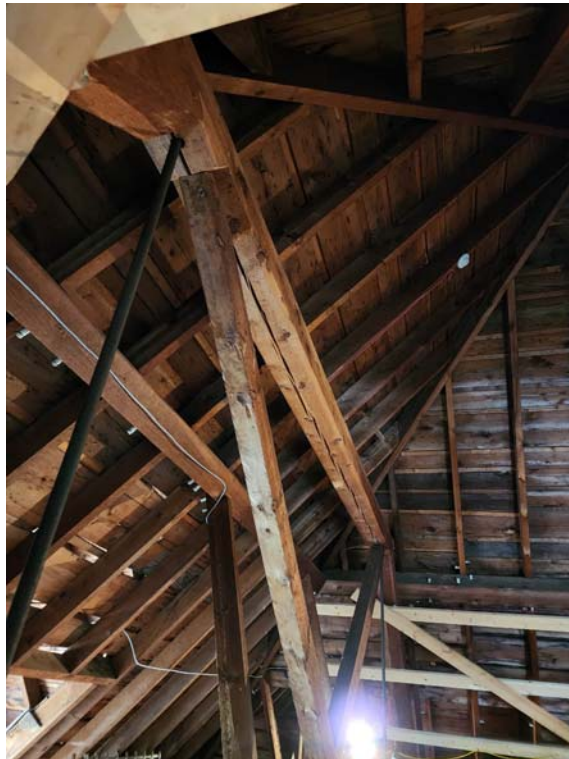
Photograph #28 (Town Hall)  
– Cracked Truss Member

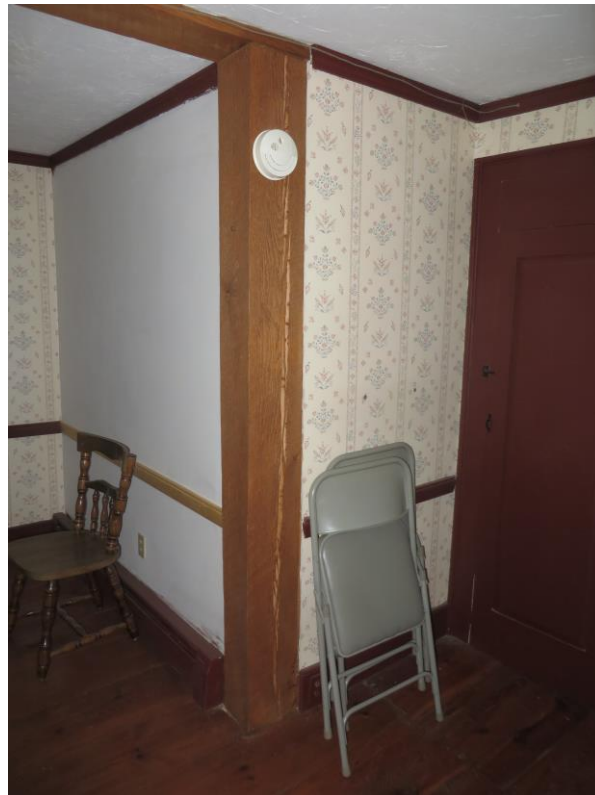
Photograph #10.1 – “Storage 1” Cracked Wood Column

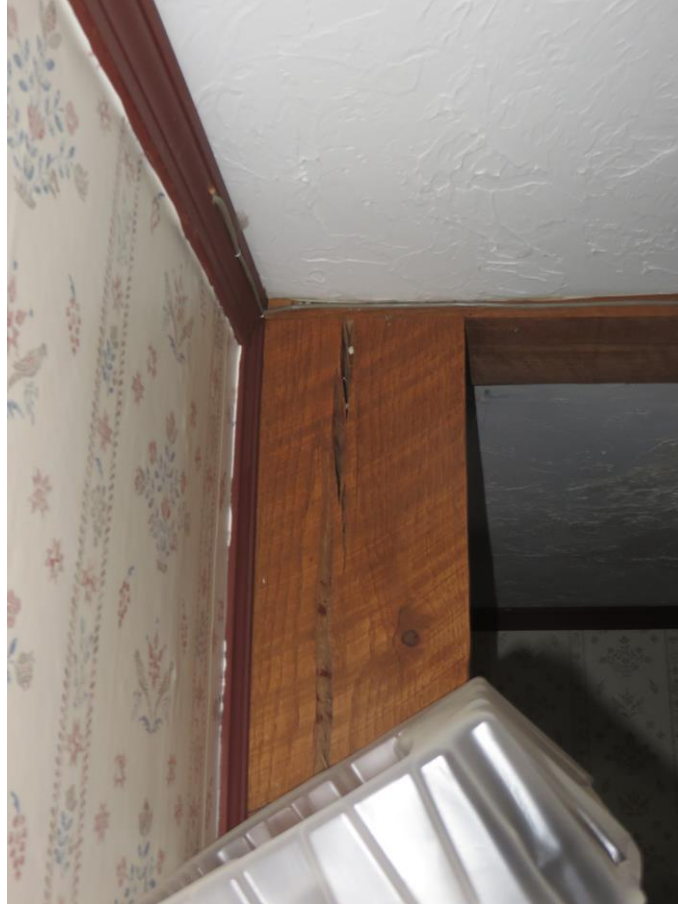
Photograph #10.2 – “Storage 1” Cracked Wood Column

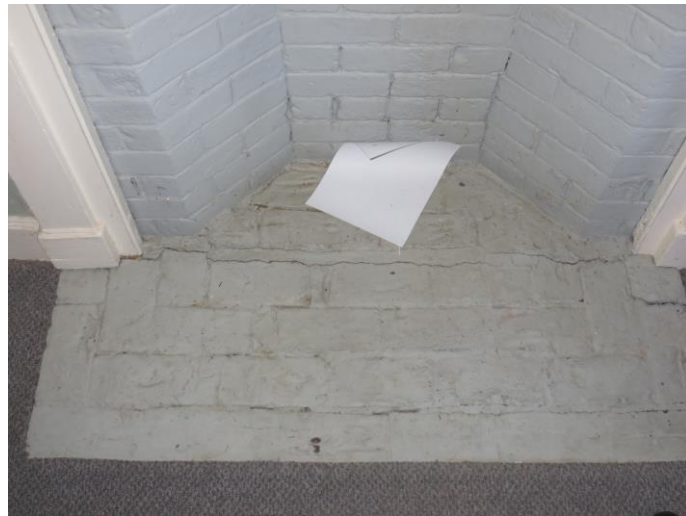
Photograph #13 – “Conservation” Cracked Masonry Hearth
