SZEWCAK ASSOCIATES
CONSULTING ENGINEERS

Re: Structural Condition Survey
Town Hall Annex
Brimfield, Massachusetts

Re: Structural Condition Survey
Existing Town Hall
Brimfield, Massachusetts

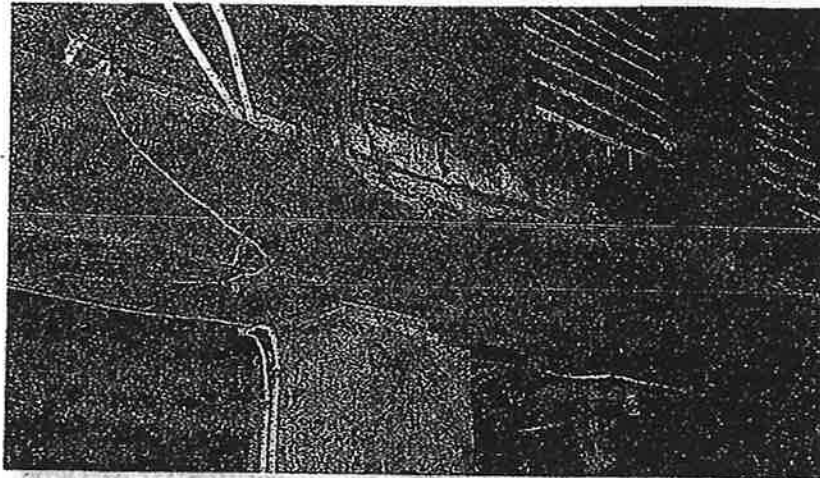
2. There is significant evidence of distress in the First and Second Floor Framing in the original, 1819 building. The floors are out of level, and the stairway is sloped and distorted. In addition, some bulging of the central bearing wall in parallel to the stairs indicates distress in the stud framing. Although the stone foundation walls and sill and in good condition, significant dry-rot has taken place throughout the floor framing above the basement and the crawl space. At some point in the past, temporary shoring jacks were installed in an attempt to support the floors settling due the observed deterioration, but this attempt at remedial action has been ineffective. In addition, significant deterioration was observed in the timber girders supporting the bearing walls above, and no temporary or permanent shoring has been installed at these locations.

Dry Rot in Floor Girder

- c. Repairs to the main building would be quite extensive, most likely requiring the evacuation and gutting of the entire space. In order to complete these repairs, the Roof and Second Floor Framing would need to be shored while the First Floor Framing is completely removed and reconstructed. The finishes would need to be removed from the central bearing wall parallel to the stairs in order to complete any repairs to the damage studs. In addition, the ceiling would need to be removed from the underside of the Second Floor in order to expose the framing, so that any additional repairs of deteriorated members or reinforcing of connections can be completed. Note also that jacking the floors back to level will most likely result in secondary damage to the finishes, doors, and windows, requiring repair or reconstruction of these items. It is our professional opinion that the probably construction cost to structurally repair the main building will be approximately Seven Hundred and Fifty Thousand (\$750,000) Dollars.

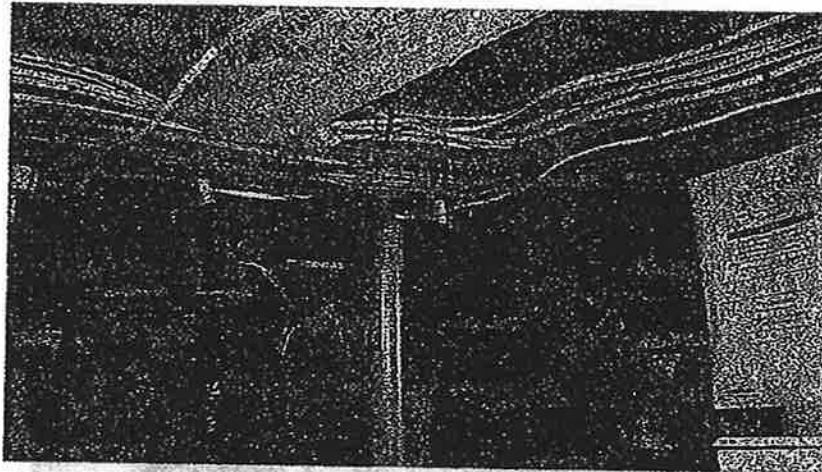
Dry Rot in Joists and Shoring Jacks

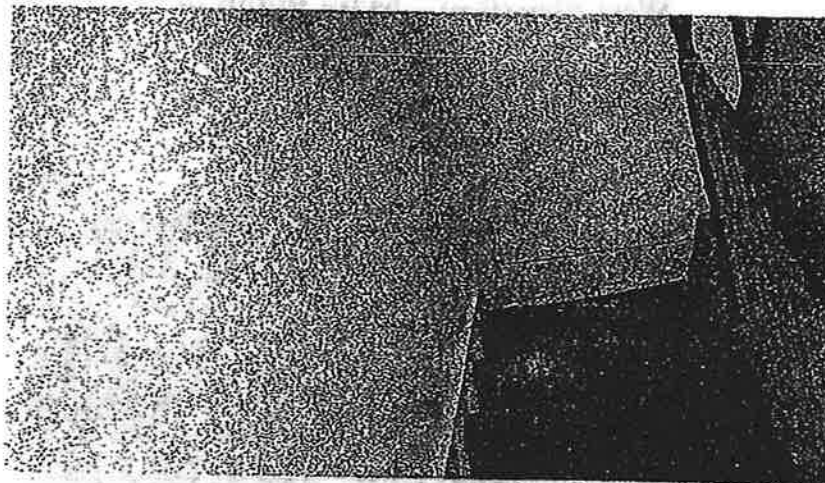
Distressed Stair Framing

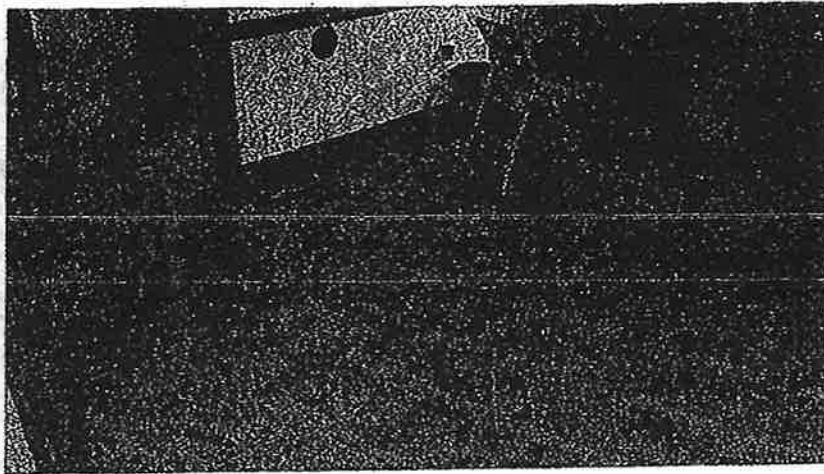
3. At one location, where the Second Floor Framing was exposed, significant distress was observed in the wood floor joist to girder connections due to the First Floor settlements, and at several locations, the floor decking has separated from the joists. In other areas, it should be noted that due to the presence of the existing plaster ceilings and walls, it was not possible to make direct visual observation of these members.

Typical Distress Second Floor Framing

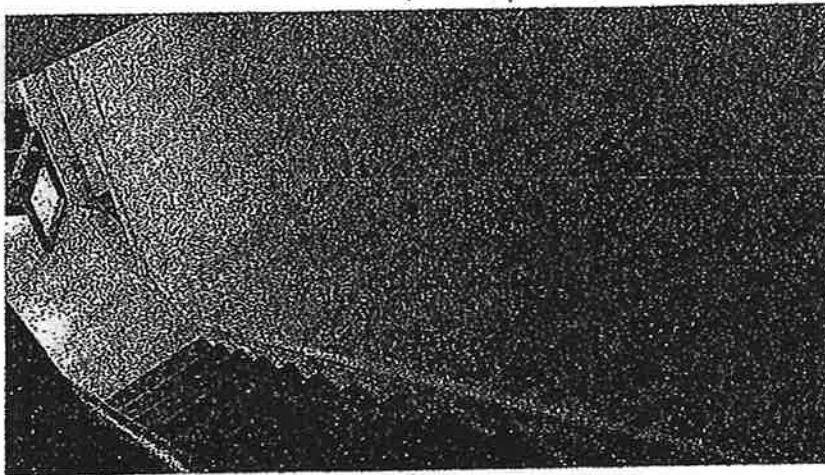
Distress in Central Bearing Wall

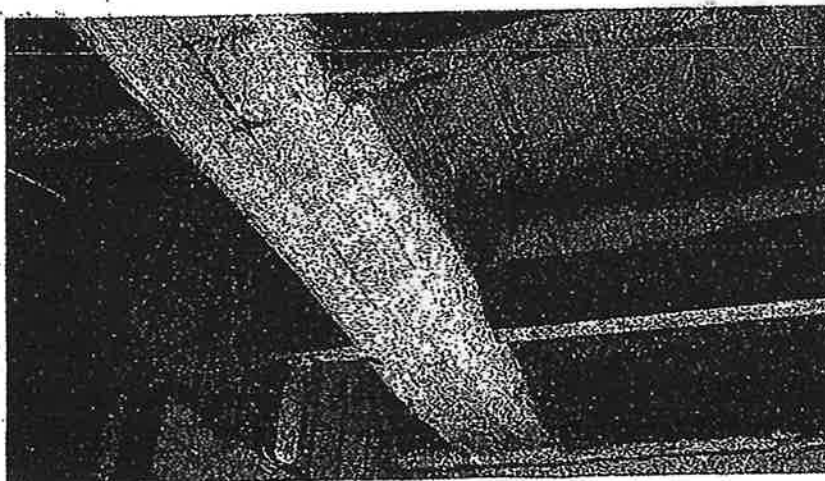
2nd Floor Connection Distress

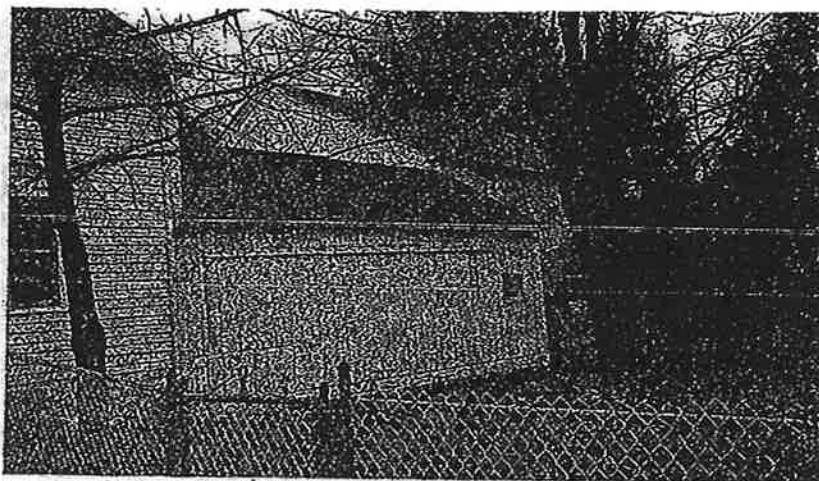
6. The one story connector between the main building and the barn is in very poor condition. It appears that the foundations do not extend to the minimum frost depth of four (4'-0") feet below grade, and significant rot has occurred in the sill plate at the top of the foundation wall. In addition, the wall siding is in poor condition with evident cracking and joint separation.

Connector Façade

- b. Given the condition of the foundations for the one story connector between the barn and the main building, it is our recommendation that this structure also be demolished. Continued use as storage is permissible in the interim, if the condition of the structure is regularly monitored.

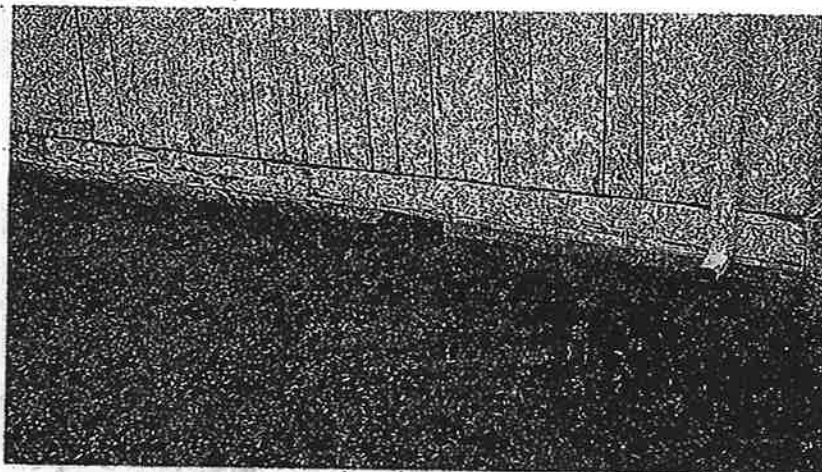
Deteriorated Connector Foundations and Sill

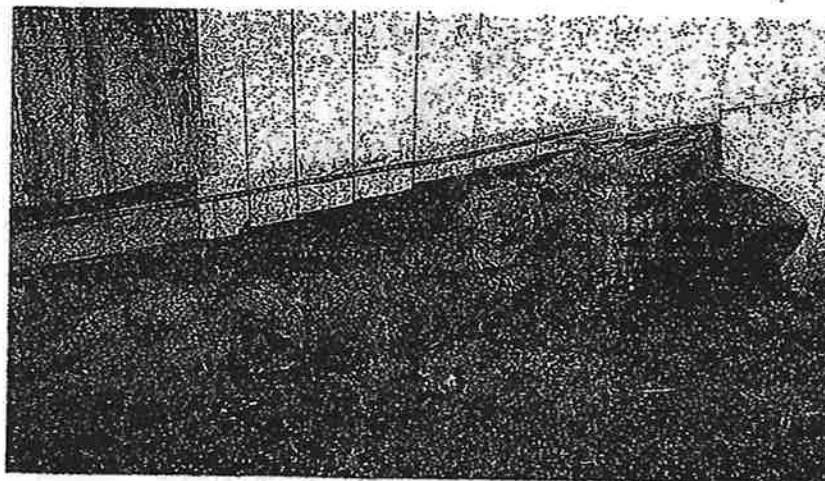
7. The pole barn structure at the rear of the building is in very poor condition. The loose laid stone foundation has suffered significant deterioration and is crumbling away. The wood sills at the top of the foundation walls have also experienced significant rot due to water exposure, as has the First Floor Framing.

Crumbling Barn Foundation

- a. The barn has very limited structural integrity, and no occupied use of this building should be permitted. It is our recommendation that the barn be demolished as soon as possible.

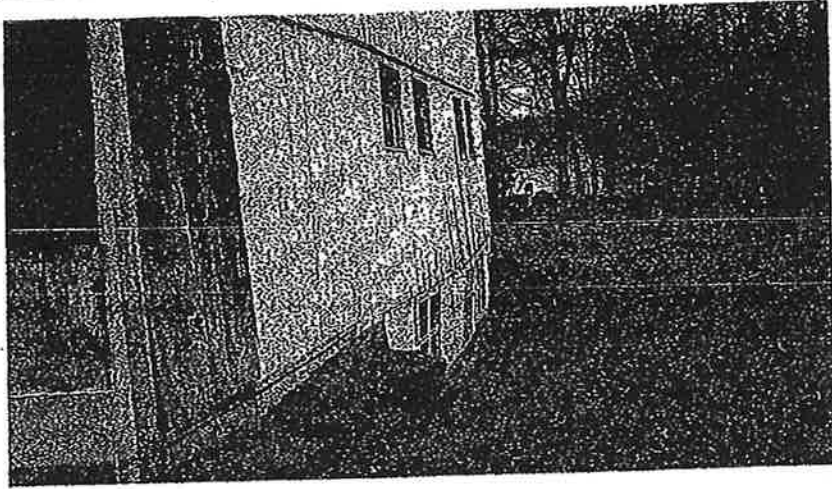
Barn Wall Deformation

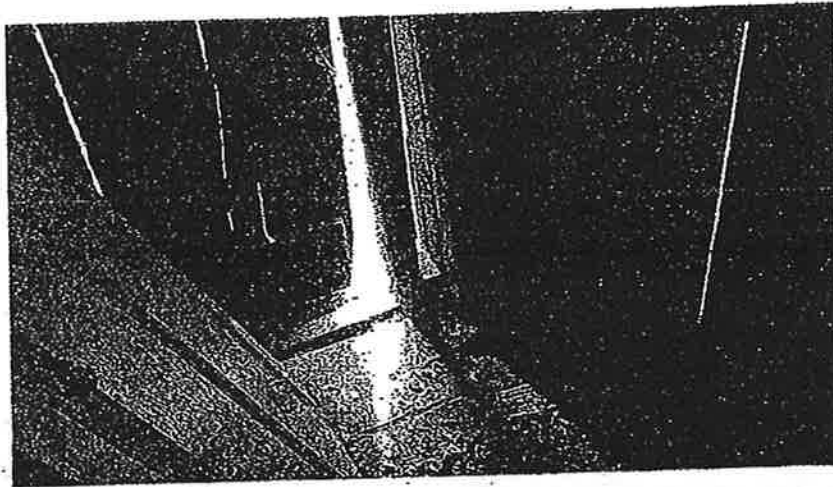
Deteriorated barn Sills

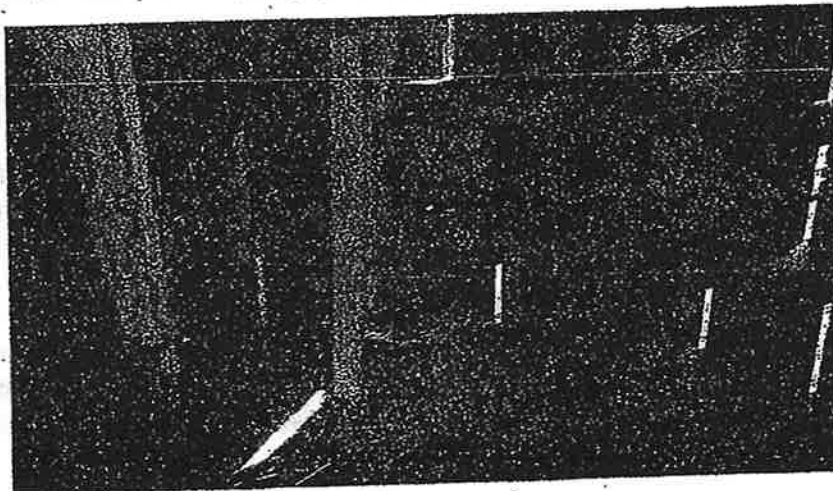
Deteriorated Barn Sills and Sheathing

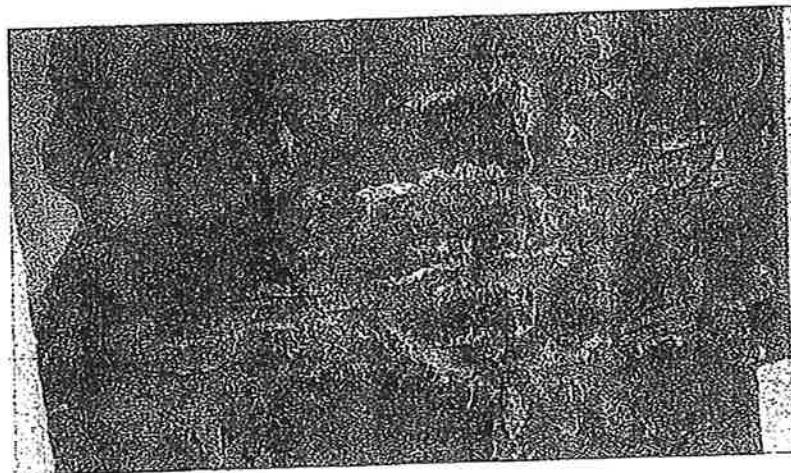
9. The brick foundation wall above grade is in good condition, however the stone foundation wall is not impermeable to surface water infiltration. On the eastern façade, the grade is lower to allow for egress out of the basement, and a ground drain is in place, so there is little evidence of moisture infiltration on this side of the building. On the western side of the building though, significant moisture infiltration has taken place and is continuing to occur. Effervescence is visible on the interior of the stonework, and in some areas, the mortar has washed out. The finishes on the interior of the basement walls are stained by water, as are several areas of the floor. This water penetration has been caused by site surface runoff since the grade slopes relatively steeply from the Town Hall Annex parking lot directly to the face of the existing Town Hall Building. Although there is not presently any significant deterioration in the integrity of the foundation system, water infiltration will continue to take place with the attendant effect on finishes and occupancy suitability. In order to repair this situation the site to the north of the building should be regraded, creating a surface swale that will drain away from the building. A yard drain should also be installed at the low point of the revised draining in order to divert any standing water. Additionally, the mortar deteriorated mortar joints between the stones should be refilled, and a foundation drainage system should be installed to the exterior of the foundation consisting of perforated piping running to an open outfall, backfilled with a free draining material.

Stone Foundation with Efflorescence

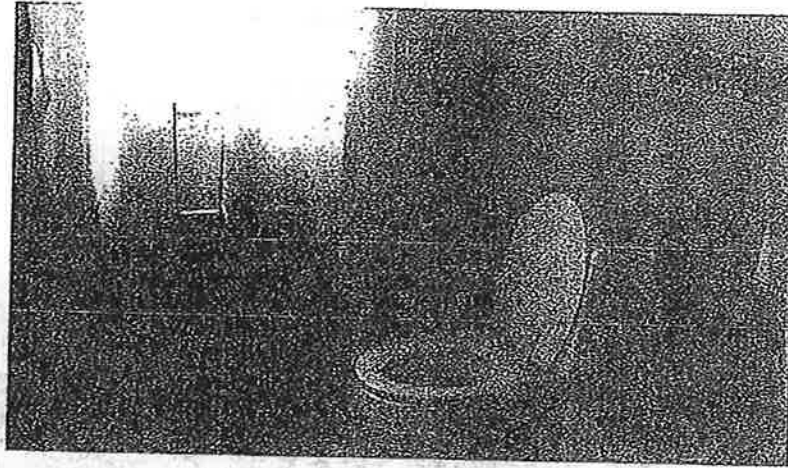
Moisture Damage in Exterior Walls

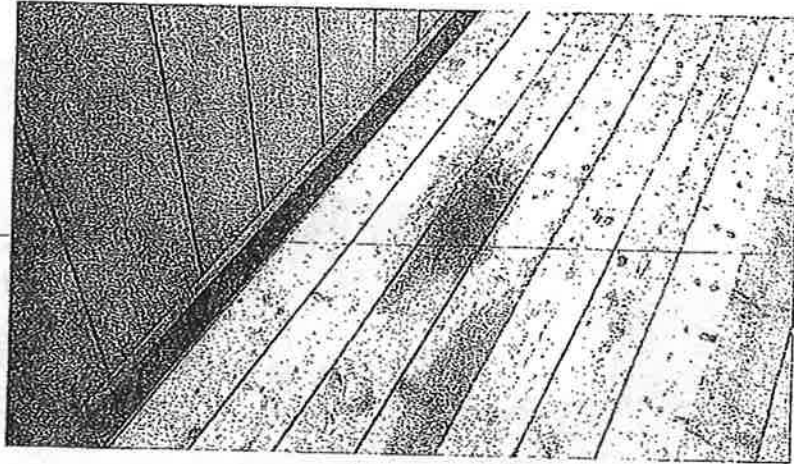
Floor Moisture Staining

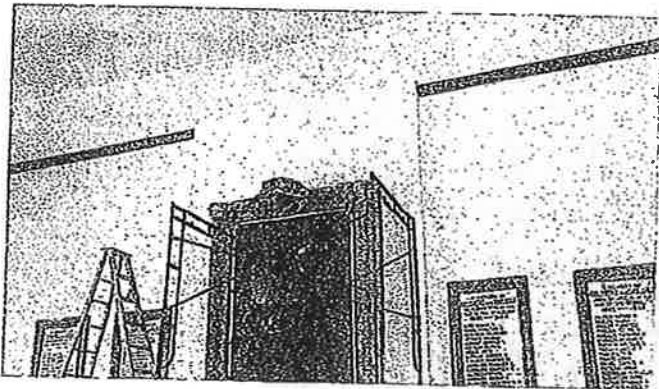
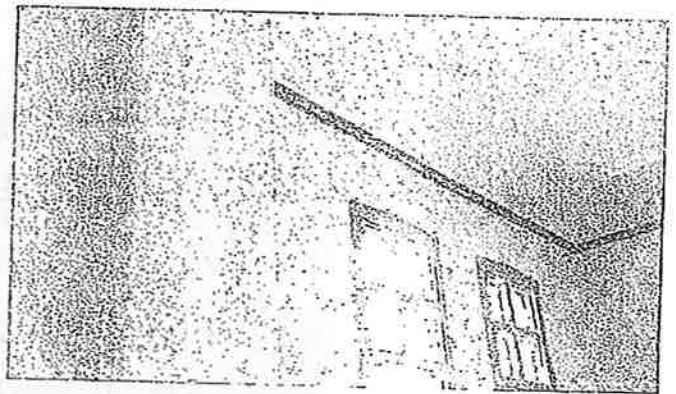
3. Recent repairs have been completed on the center roof truss and the top of the interior wood framing where deterioration had been caused by moisture penetration. The repairs consisted of reinforcing the existing framing with the addition of new steel plates and members. It appears that these repairs have been satisfactorily completed, and no further deterioration is evident in the roof framing. Some minor cracking of the wall plaster is visible, but this was most likely caused by the forces impacted to the structure by the jacking and repairs of the existing framing.

Minor Plaster Cracking in Meeting Hall

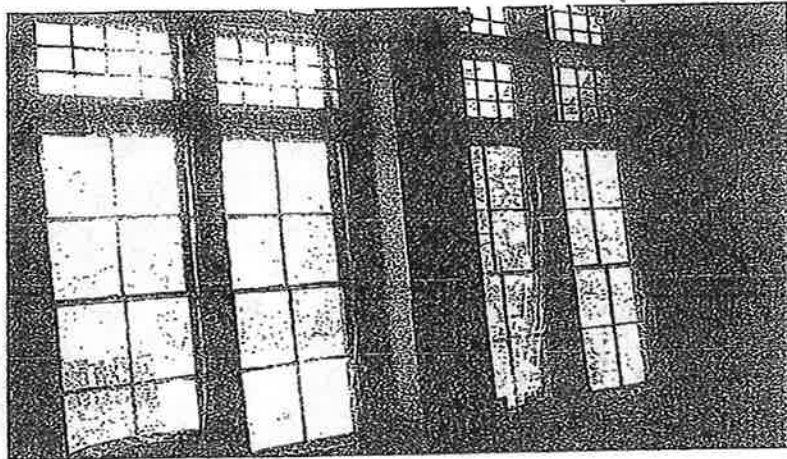
5. All the building windows consist of single pane glass, and they are broken or cracked in several locations.
6. The First and Second Floor wood framing is in good condition with no visible evidence of distress or significant deformations.

Typical Single Pain Windows

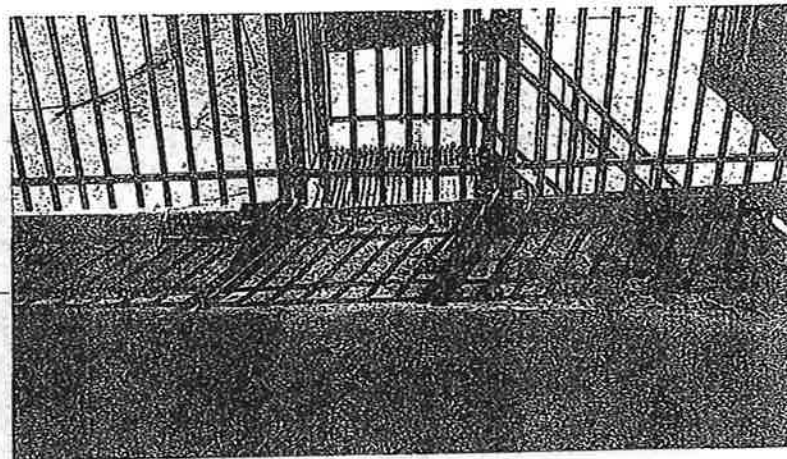
4. The majority of the roofs are sloped and shingled, and appear to be in good condition with no visible evidence of deterioration or moisture penetration. Where the second floor accesses the fire escape to the rear of the building, there is a small area of built-up roofing on a flat surface. This roof also appears to be in good condition with no visible evidence of deterioration or moisture penetration.

Flat Roof at Top of Fire Escape

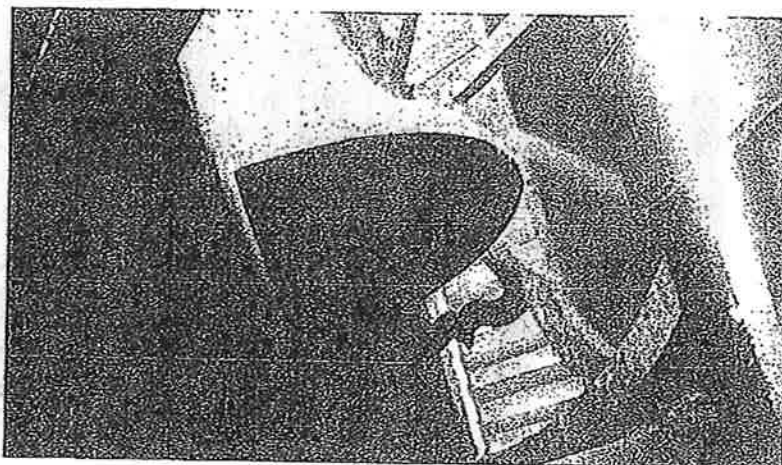
7. The bell tower at one corner of the roof appears to be in good structural condition, however, its interior is covered with avian waste that should be cleaned out and remediated as soon as possible.

Interior of Bell Tower

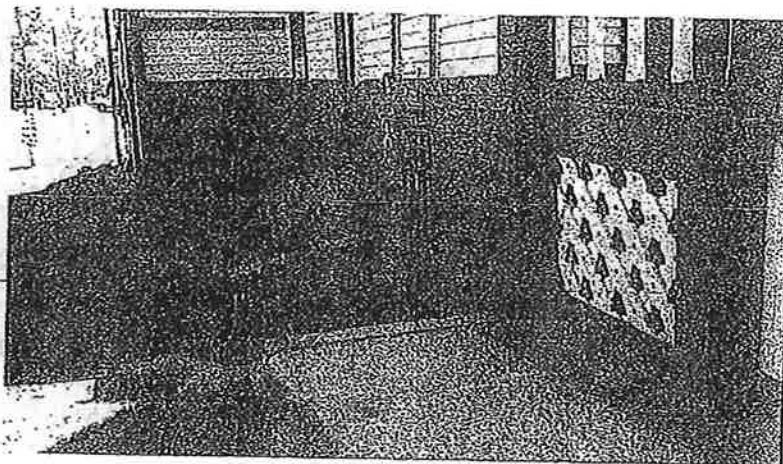
Surface Drain & Grading on East Side

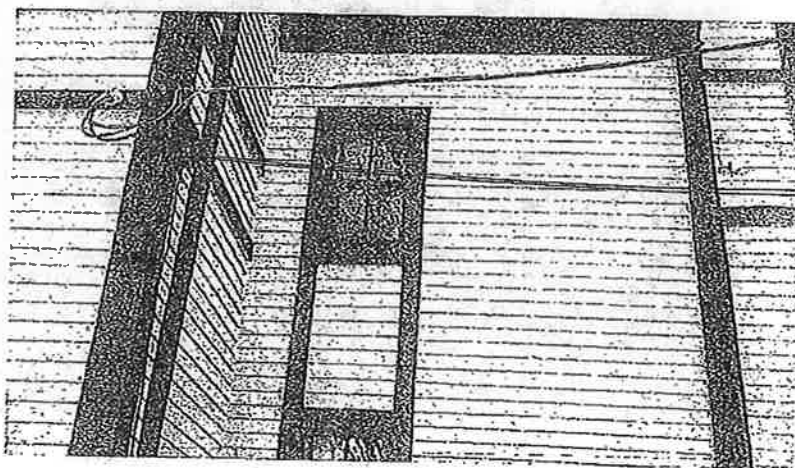
Broken Window on East Facade

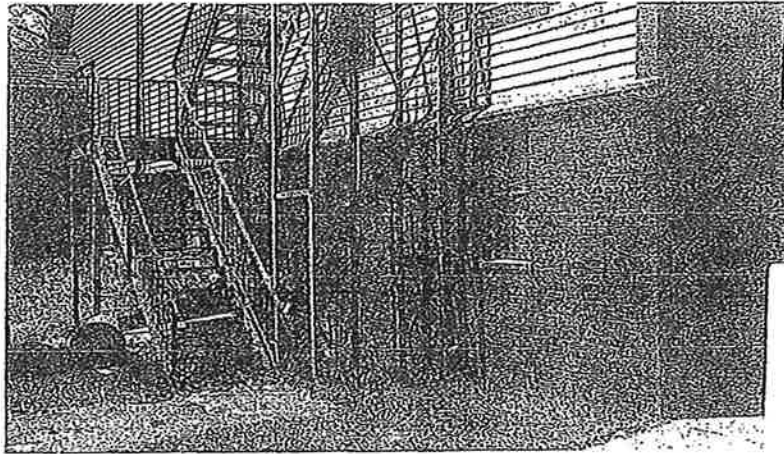
10. The rear fire escape on the south façade of the building is in good condition structurally; however, several treads are damaged and should be replaced. In addition, the paint is peeling off most of the members. The fire-escape framing should be cleaned and repainted to prevent rusting and deterioration.

Fire Escape on South Facade

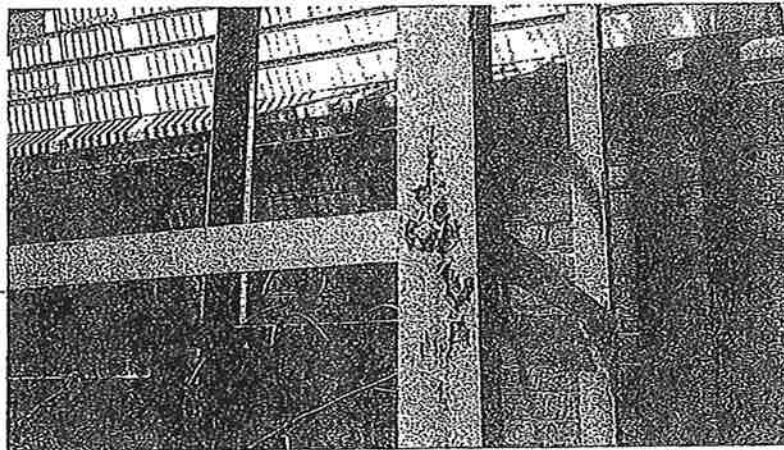
Deteriorated Fire Escape Paint

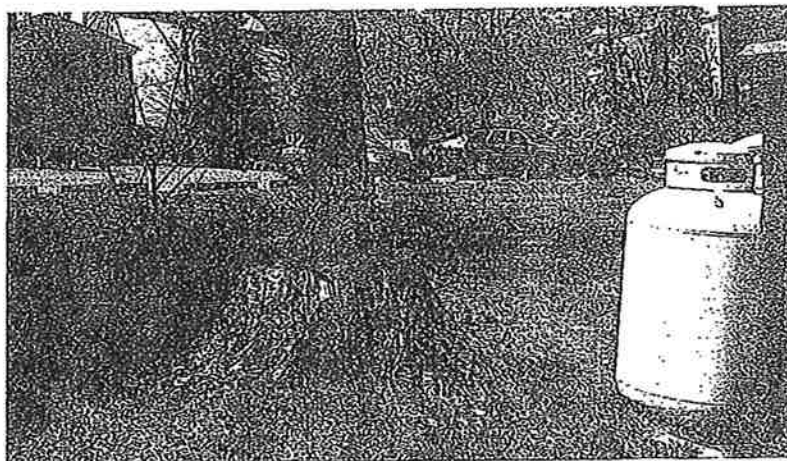
East Side Surface Ground Sloping Toward Building
