# Town of Brimfield, Massachusetts

## Town Building Assessment Study

## Capital Master Plan

February 24, 2014

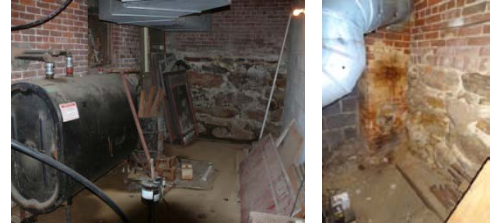
2 In Mechanical #1 the exterior stone foundation wall and the first 2 course of brick are deteriorating due to water infiltration. These walls show numerous repairs made over the years. This area of the room has a sump pump in the floor slab and at the time of the inspection there was water on the floor. Replace damaged brick and re-point existing brick chimney for the first 4' above the slab.

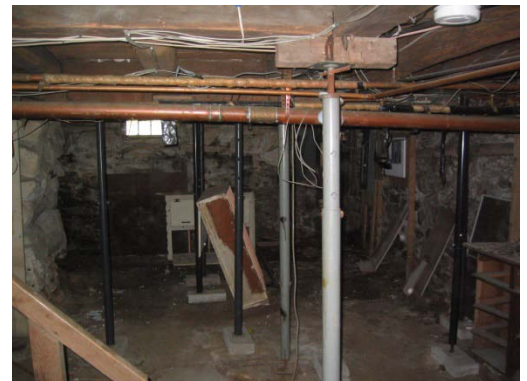
- To the south of the Basement, First Floor joists over the crawl space (1¾"x6 ¾" @ 21" o.c. – photo right) in the original house are inadequate for office use. The floor is flexible under foot. The balance of the First Floor structure (further to the south) is flexible and uneven, suggesting that similar conditions are present throughout. FBRA recommends that First Floor framing over the crawl space be thoroughly evaluated and reinforced as required to increase capacity for the intended use, in conjunction with future renovations to the building. In the meantime, caution should be exercised in placing heavy loads (file cabinets, equipment, etc.) in these areas.

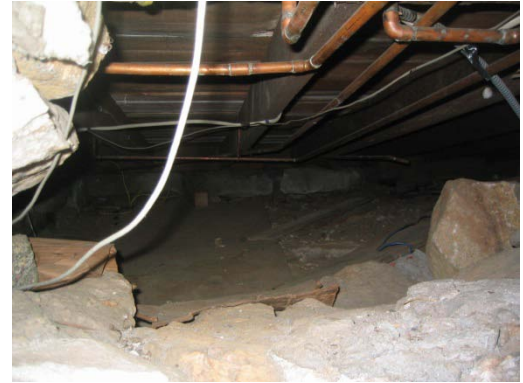
- Rubble stone foundation walls in the original house have taken on moisture over the years and show signs of deterioration. Mortar has desintegrated and turned into powder in some areas; elsewhere, mortar appears to be relatively intact. FBRA recommends that roof and surface drainage be evaluated in conjunction with future renovations to the building. Roof and surface water should be directed away from foundation walls and wall joints should be raked and repointed as required.

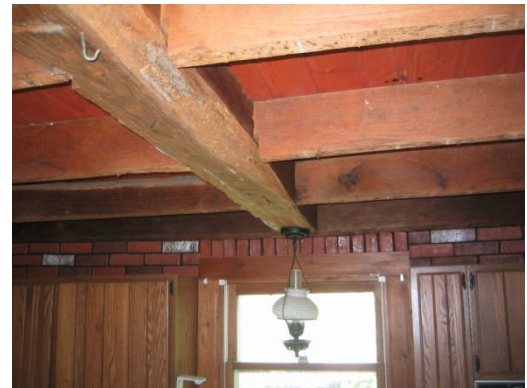
- Second Floor framing in the original house is flexible under foot. The floor construction sags considerably; particularly at the back/southern section. Member sizes/spans could not be determined; however framing may be similar to that observed at the Attic space above. The 8"x 7½" beam which spans in the east-west direction (approximately 16 feet) has limited capacity to support live load. FBRA recommends that Second Floor framing be thoroughly evaluated and reinforced as required to increase capacity for the intended use, in conjunction with future renovations to the building. In the meantime, caution should be exercised in placing heavy loads (file cabinets, equipment, etc.) at this level.

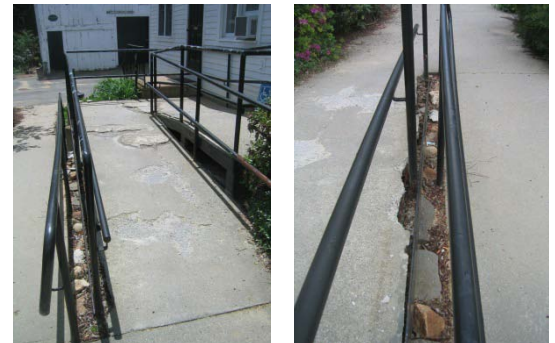
- The handicap ramp on the east side of the original house (photos right) has deteriorated significantly; likely due to moisture and de-icing salts. Repair or replacement is required.

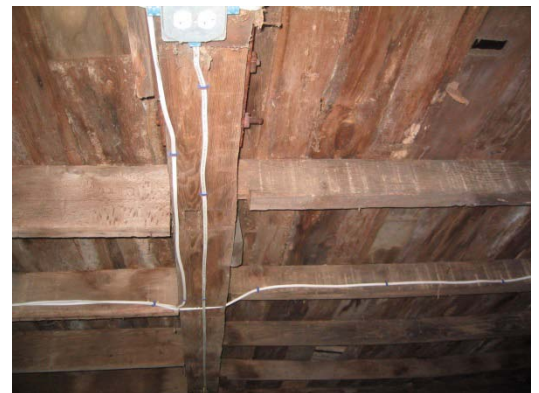
- As noted above, it appears that a supporting post for the central, north-south Loft Floor beam in the Barn has been removed. In the absence of the column, this beam has little or no live load capacity. FBRA recommends that the beam be temporarily shored, without delay. Loft Floor joists in the western bay (right hand side in photo at right - 3"x4½" @ 2'-6" o.c., spanning 10½ +/- feet) have minimal live load capacity and have deflected considerably. FBRA recommends that joists in this bay be temporarily shored and/or that (storage) loading be removed.

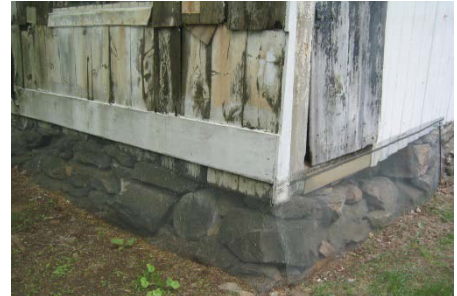
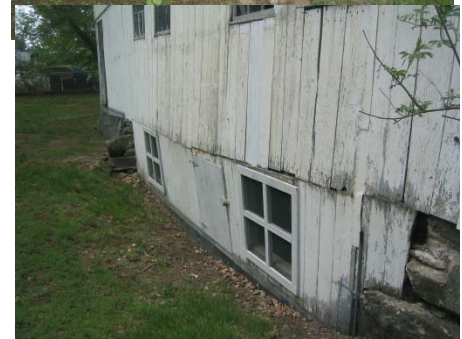
- Barn roof construction was observed (from a distance) and generally appears to be performing satisfactorily; however, walls and foundations supporting this construction are in poor condition, as noted below.
- The rubble stone foundations of the Barn are in poor condition (photo right) and have failed in some locations (e.g. the southwest corner). It appears that the foundation is beyond repair, FBRA recommends that a new foundation be constructed if the Barn is retained/rebuilt.
- The wood framed exterior walls of the Barn are in poor condition and have failed in several locations. Walls are bowing out at the First Floor and Loft Floor levels on the back (south) and west sides of the structure. Wall construction at the southeast corner has failed. There are a number of areas where wood trim/cornices are rotted and/or missing, allowing water to enter the building.

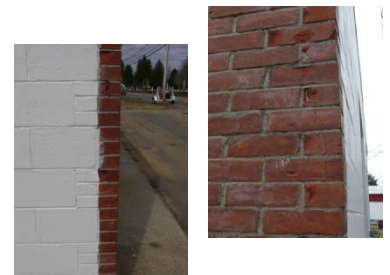
- 2 Bricks at corner of east wall are spalling. Replace damaged brick. Saw cut a joint between brick and CMU to create an expansion joint. Add filler, backer rod and sealant to joint.

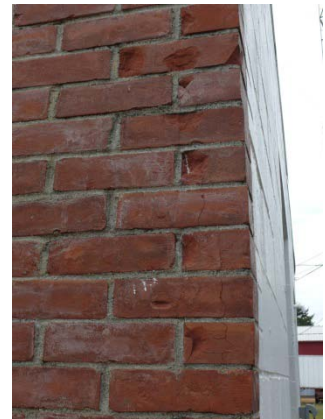
- The condition of the exterior brick veneer is generally satisfactory; however some cracking was observed and repair/repainting is required in certain locations.
- The capacity of the roof framing was not determined (steel joists are a proprietary design) ; however, roof framing appears to be functioning as originally intended. One area of potential concern is at the junction of the high and low roofs; it does not appear that snow drift loading was accounted for in the original design.
- Steel roof framing is unprotected and has no fire resistance rating. There are no sprinklers. Fire rating requirements should be reviewed in conjunction with future renovations to the facility.

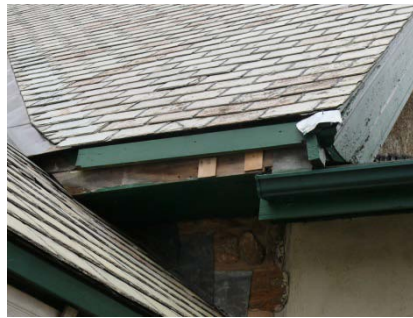
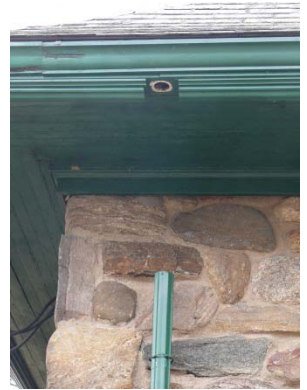
- There are damaged/missing areas of roof trim at a number of locations around the building. Downspouts are disconnected and some downspouts do not properly direct water away from the foundation walls. If not repaired, these conditions will continue to allow moisture into the building and allow water to build up behind foundation walls.

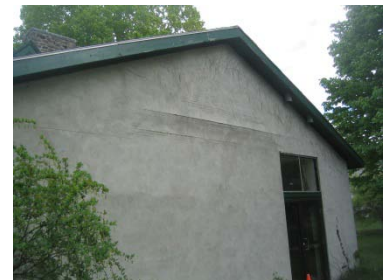
- The exterior stucco finish at the back, gable end wall of the Sherman Memorial Room is failing and has bowed outwards. This condition should be repaired to prohibit moisture from entering the walls.
- Wood framing may typically be protected (to a degree) by the ceiling construction; however, elsewhere it is unprotected. There are no sprinklers. Fire rating requirements should be reviewed in conjunction with future renovations to the facility.

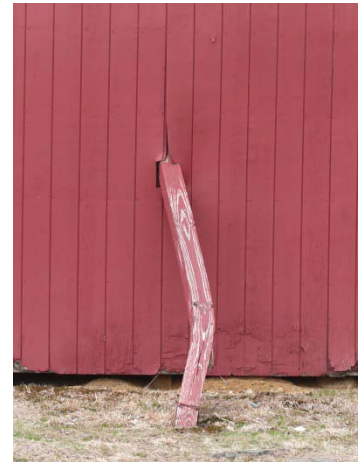
- The wood framed roof and wall construction of Shed No. 1 and Shed No. 2 appears to be quite light (not uncommon for unoccupied storage building); further review/evaluation is recommended in conjunction with future plans for the grounds surrounding the Garage. The wood buttresses that laterally brace the lower, double wall construction of Shed No. 1 have been overstressed in the past; one brace has noticeably failed.
