JSE JOHNSON STRUCTURAL ENGINEERING, INC.

Re: Structural Inspection
Brimfield Town Hall Annex & Town Hall Buildings

Re: Structural Review
Town Hall Annex
Brimfield, MA

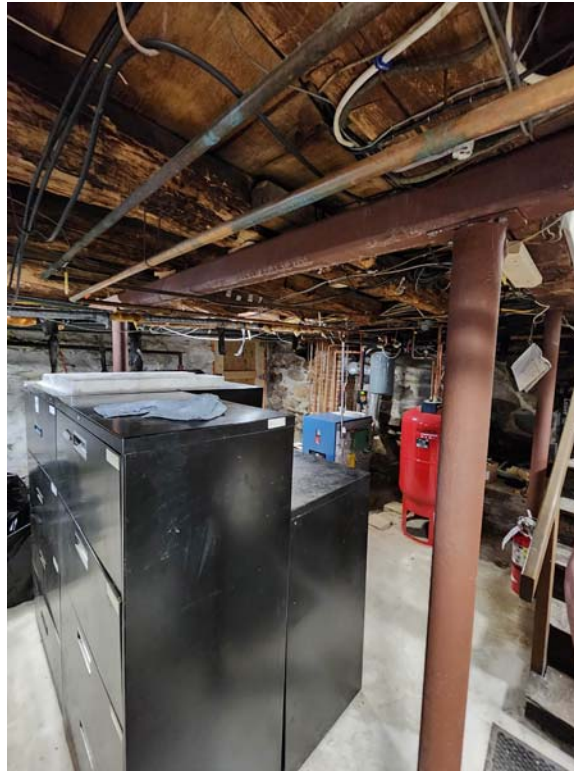
Item 15 in JSE's 2016 report discusses temporary screw jack shoring that was previously installed to support the existing first floor structure. The screw jack shoring has since been replaced with new steel shoring comprised of W-shape steel beams, HSS steel tubes and steel lally columns (see photographs #1 and #2). However, the steel framing does not appear to have been designed or approved by a structural engineer due to (a) the hardware used to connect the beams to the columns (see photographs #3 and #4), (b) the wood blocking that was installed to support the steel beams on the foundation wall (see photograph #5), (c) how the existing floor joists (round logs) were planed where needed to install the steel beams (see photograph #6), and (d) the thickness of the wood shims that were installed between the existing floor joists (round logs) and the steel beams (see photograph #7).

Photograph #1 (Town Hall Annex)
– First Floor Shoring

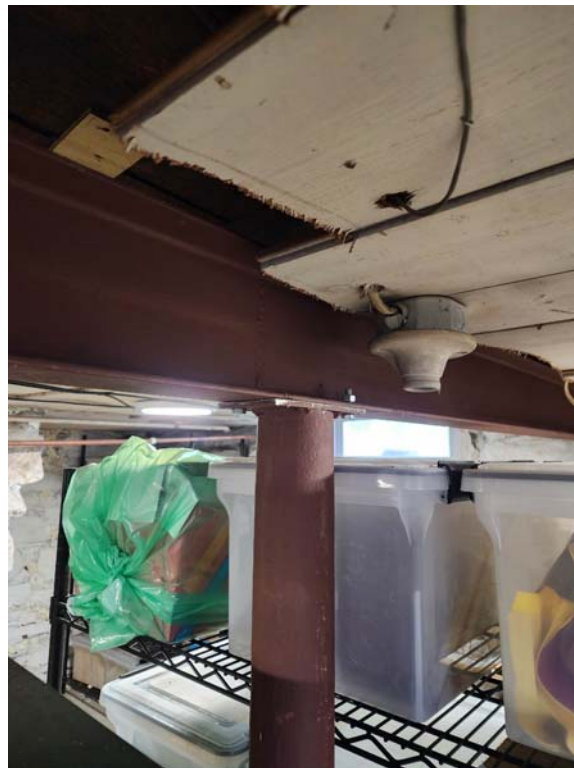
Photograph #2 (Town Hall Annex)
– First Floor Shoring

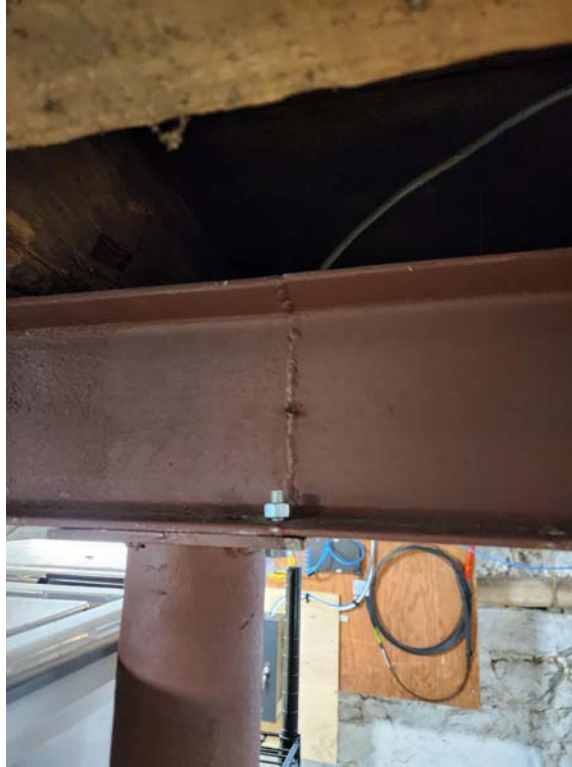
Photograph #3 (Town Hall Annex)
– First Floor Shoring Member Connections

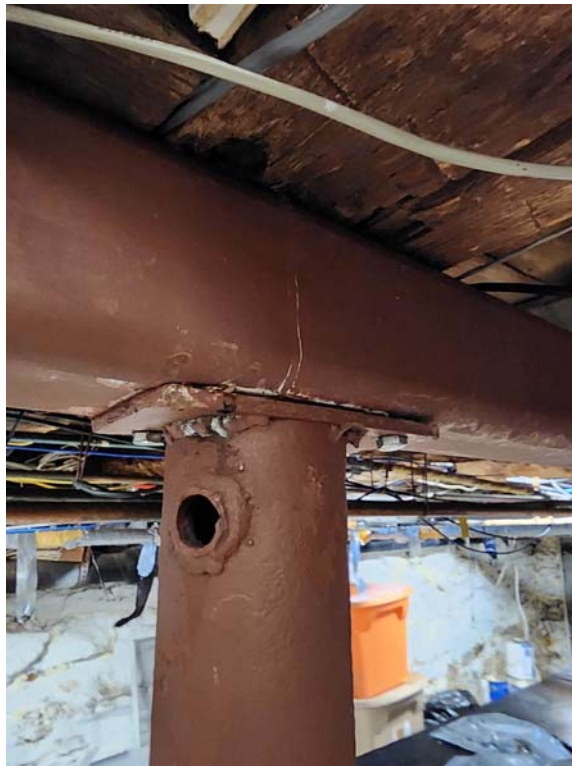
Photograph #4 (Town Hall Annex)
– First Floor Shoring Member Connections

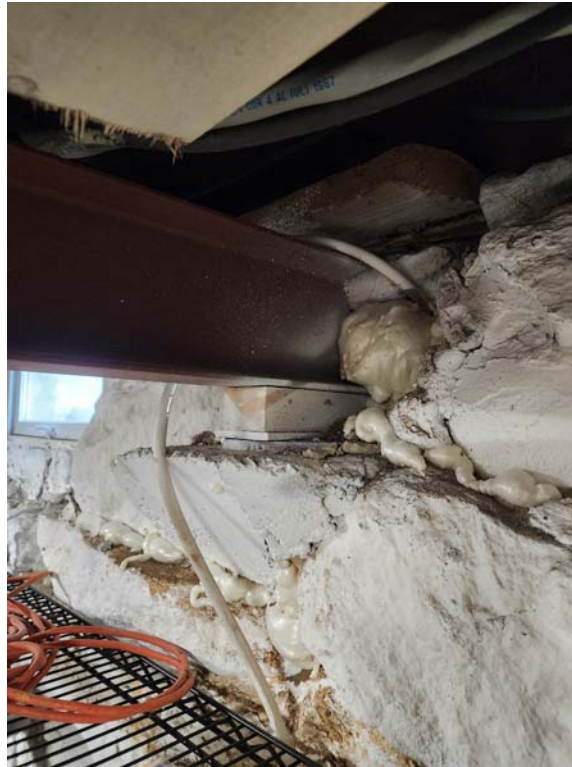
Photograph #5 (Town Hall Annex)
– Shoring Beam Bearing

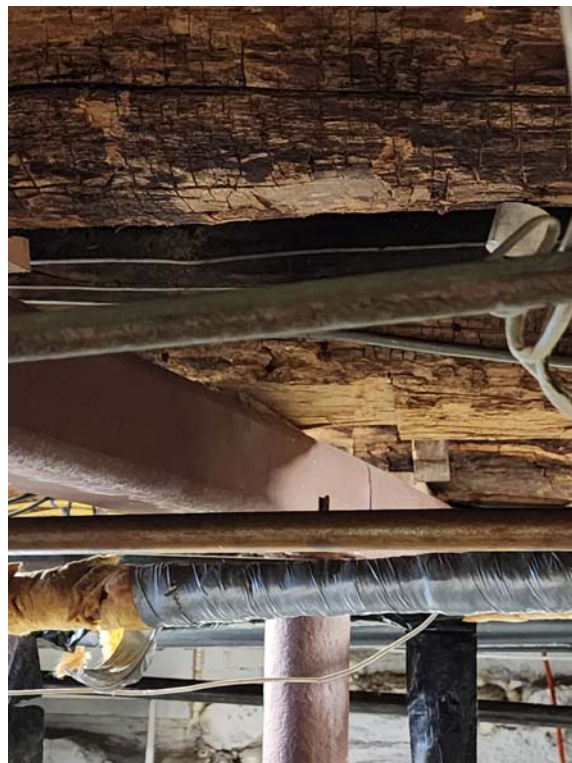
Photograph #6 (Town Hall Annex)
– Plained Floor Joists Above Shoring

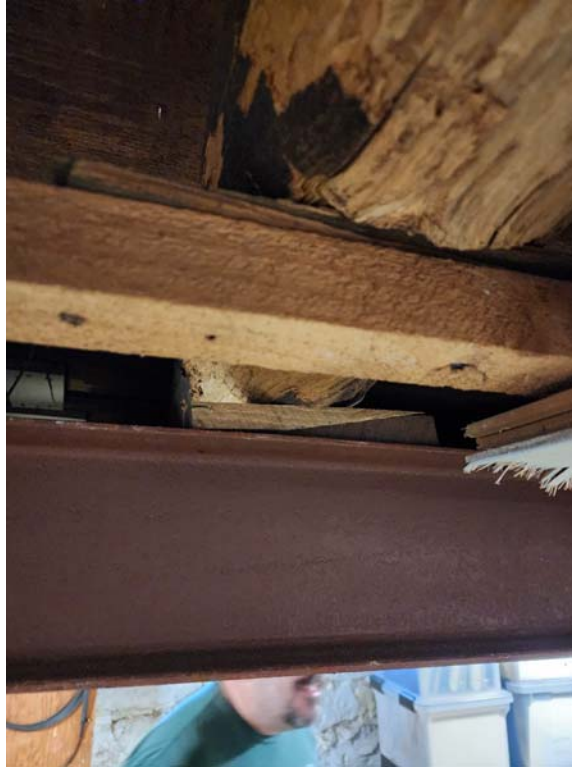
Photograph #7 (Town Hall Annex)
– Wood Blocking Above Shoring

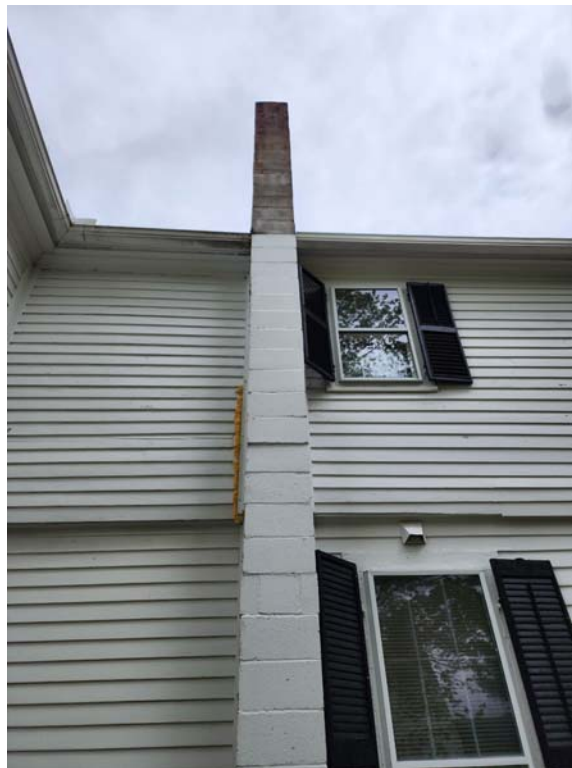
Comparing photographs taken from JSE's site visit in 2016 to JSE's site visit on May 4, 2023, there appears to have been some horizontal movement in the chimney located on the right side of the building when viewed from Main Street (see photograph #8).

Photograph #8 (Town Hall Annex)
– Chimney

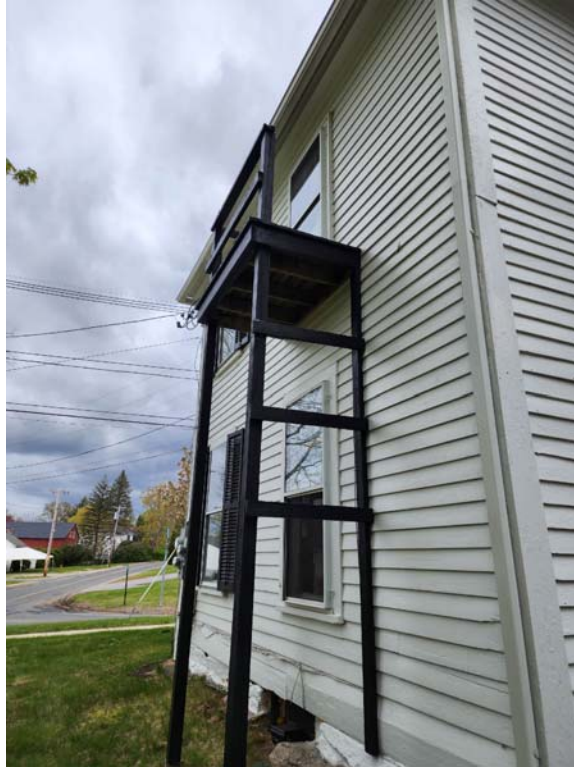
The existing deck/fire escape structure located on the second floor level along the right side of the building does not have a ladder or stair down to grade, is missing a guard along one side, and the rails are structurally inadequate (see photograph #9).

Photograph #9 (Town Hall Annex)
– Exterior Fire Escape

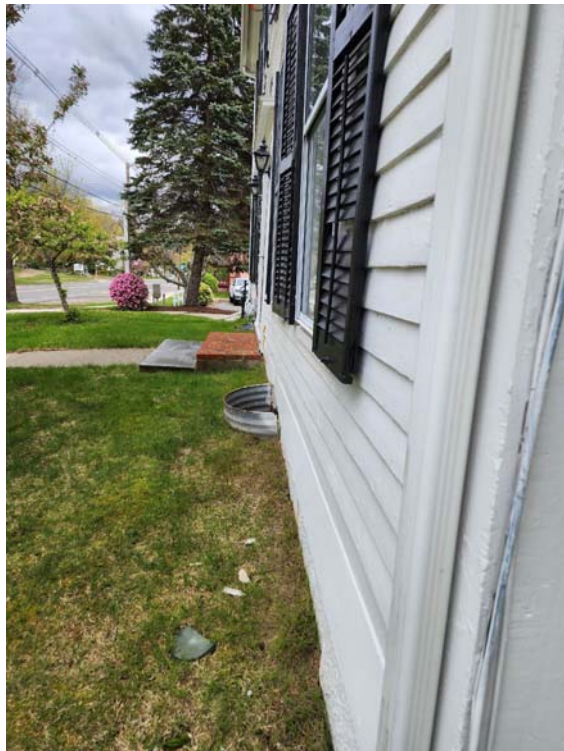
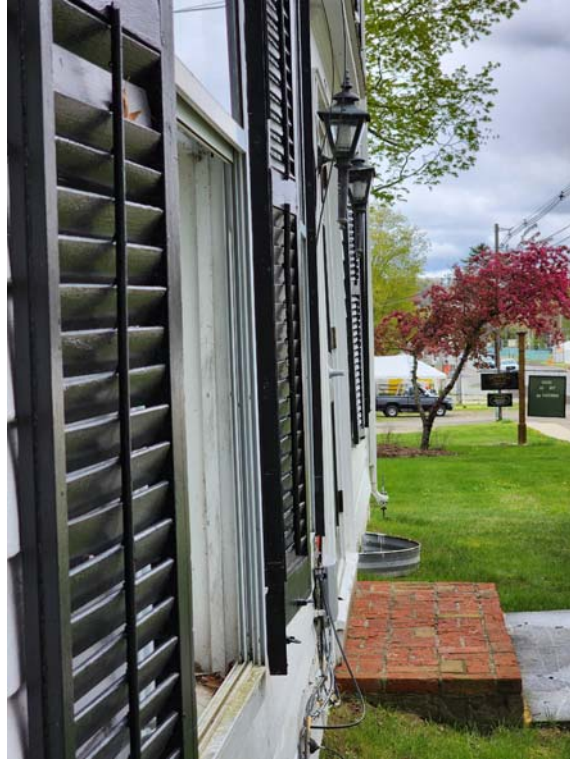
As noted in JSE's 2016 report, the front wall is bowed and appears to have an inward lean (see photographs #10 and #11). It was observed during the most recent site visit that the exterior wall along the left side of the building (when viewed from Main Street) also has an inward lean (see photograph #12). Using a laser measurer, it appears that this wall is around 4" to 5" out of plumb. There has also been settlement in the exterior grade at this corner of the building as evidenced by the exterior stairs (see photograph #13).

Photograph #10 (Town Hall Annex)
– Bowed & Leaning Front Wall

Photograph #11 (Town Hall Annex)
– Bowed & Leaning Front Wall

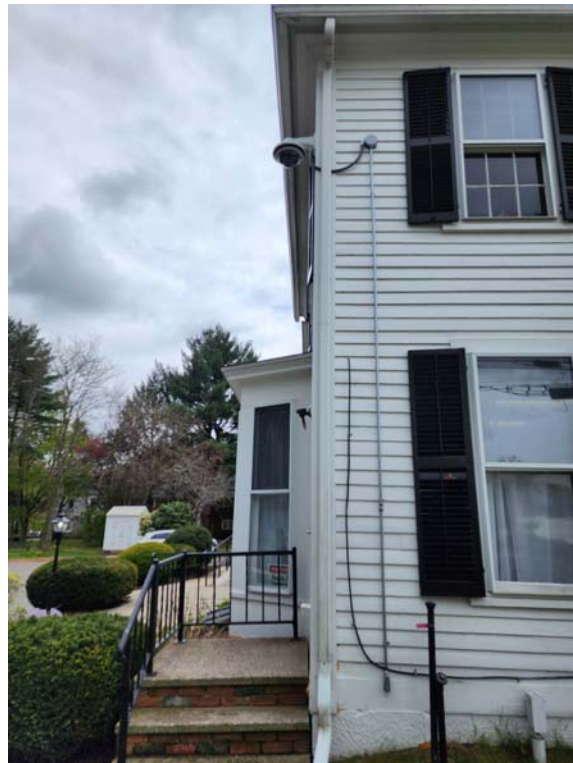
Photograph #12 (Town Hall Annex)
– Leaning Side Wall

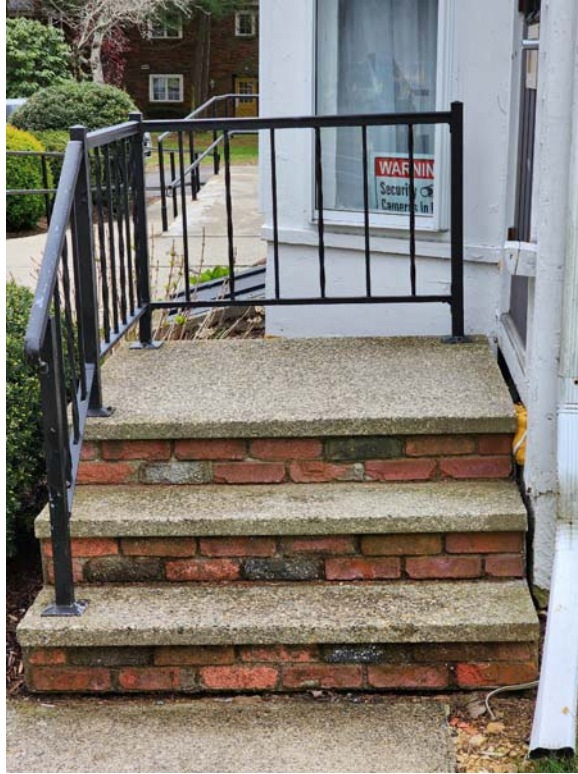
Photograph #13 (Town Hall Annex)
– Sloped Exterior Side Stairs

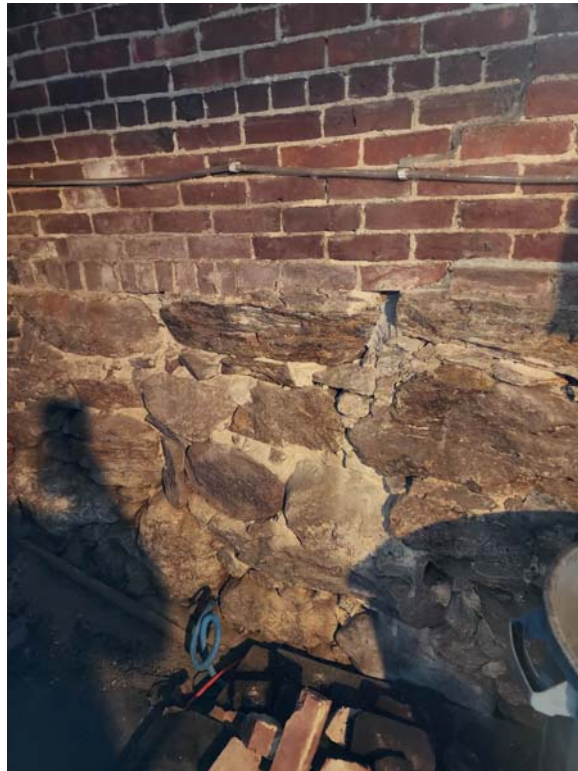
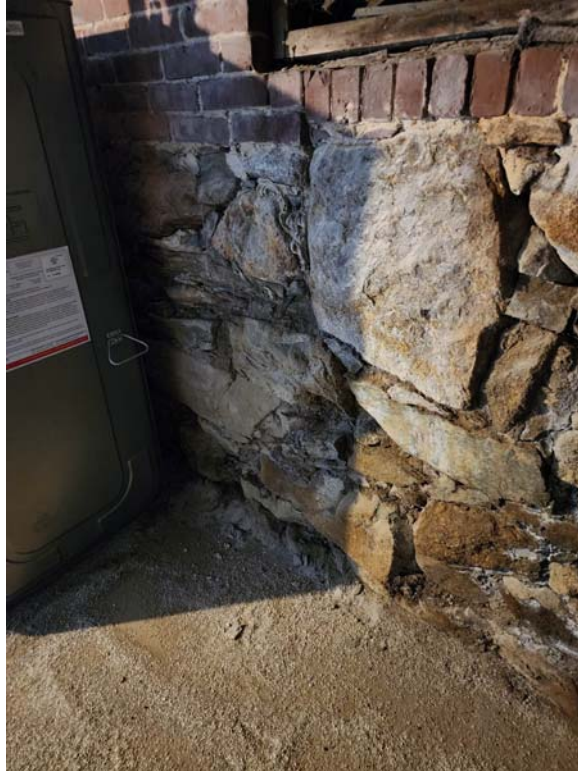
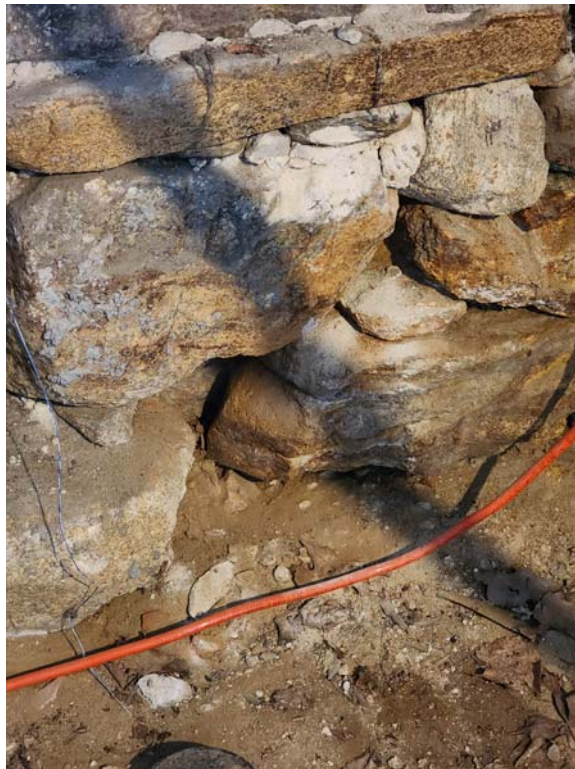
- The existing foundation is comprised of field stone and masonry. The mortar in the masonry joints and field stone joints are deteriorated (see photographs #14 through #16).

Photograph #14 (Town Hall)
– Deteriorated Masonry/Field Stone Mortar Joints

Photograph #15 (Town Hall)
– Deteriorated Masonry/Field Stone Mortar Joints

Photograph #16 (Town Hall)
– Deteriorated Masonry/Field Stone Mortar Joints

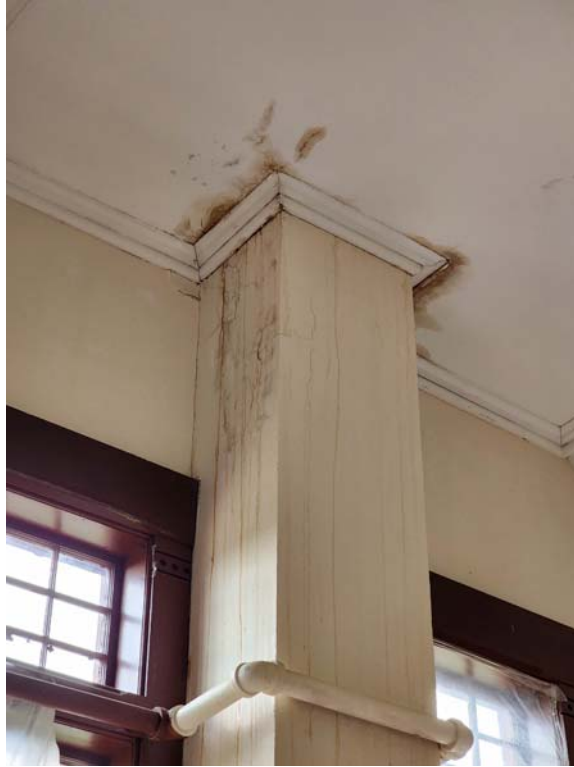
- There are signs of water damage at the second floor level (see photograph #17).
- The low, flat roof in the rear of the building is in poor condition (see photograph #18).

Photograph #17 (Town Hall)
– Interior Water Damage

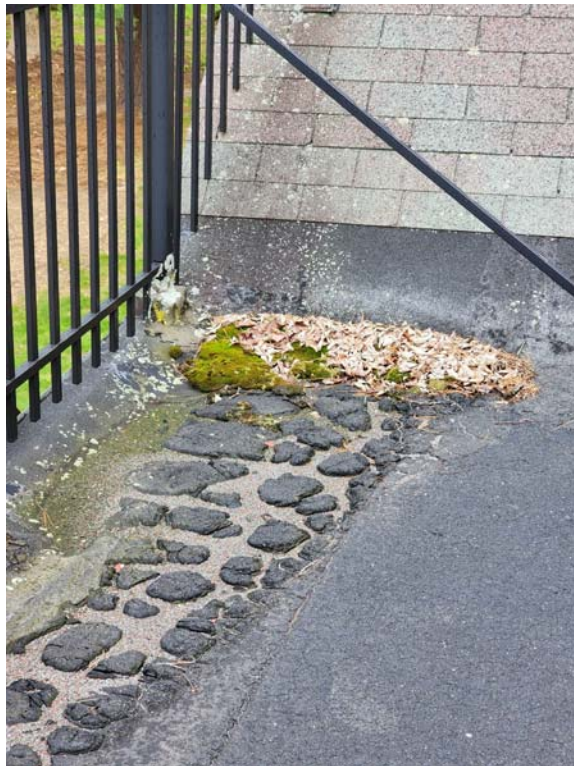
Photograph #18 (Town Hall)
– Low Roof

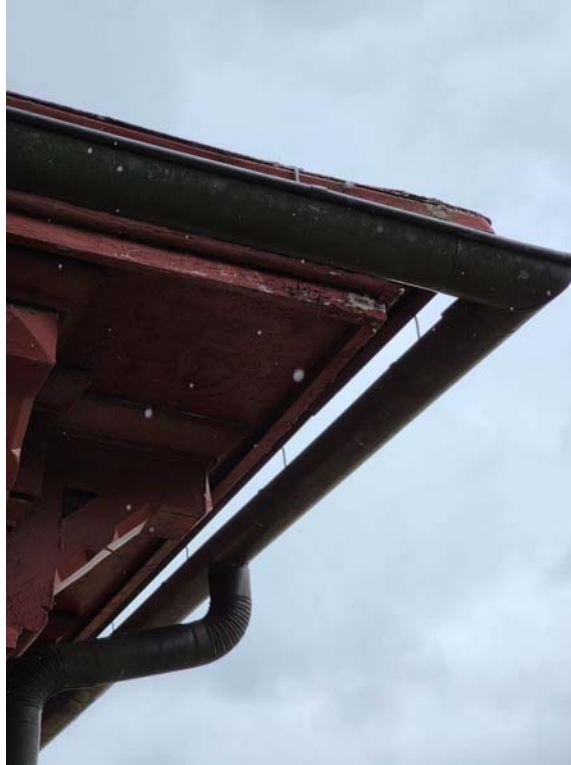
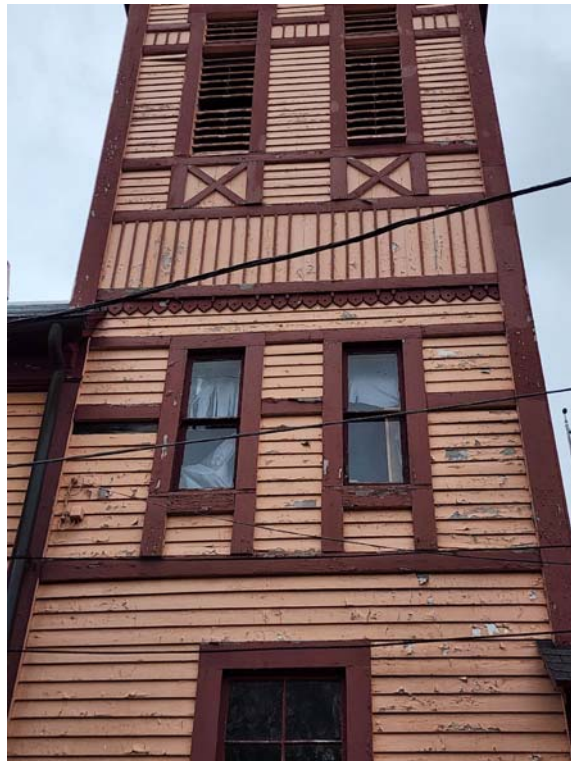
- There is likely a lot of rotted wood trim around the eaves, windows, doors, etc. (see photographs #19 and #20).
- The exterior masonry at the foundation requires repointing and replacement where deteriorated (see photographs #21 and #22).

Photograph #19 (Town Hall)
– Rotted Wood Trim

Photograph #20 (Town Hall)
– Exterior Wood Siding & Trim

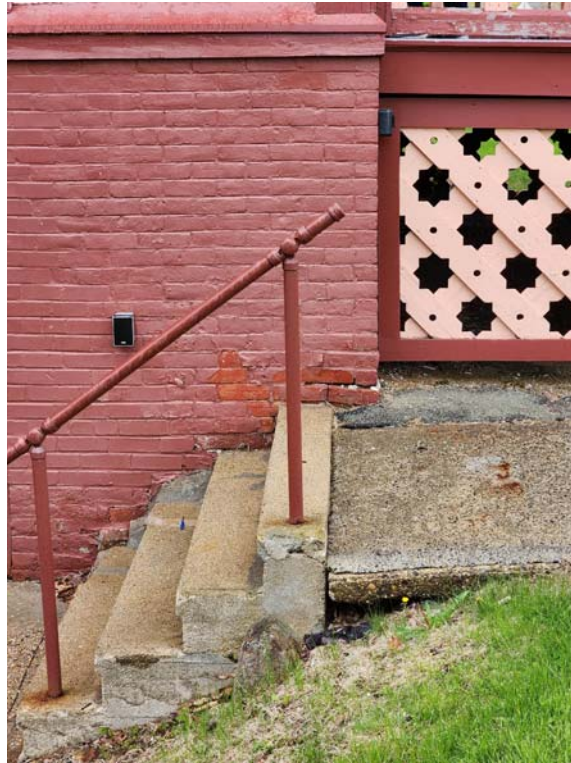
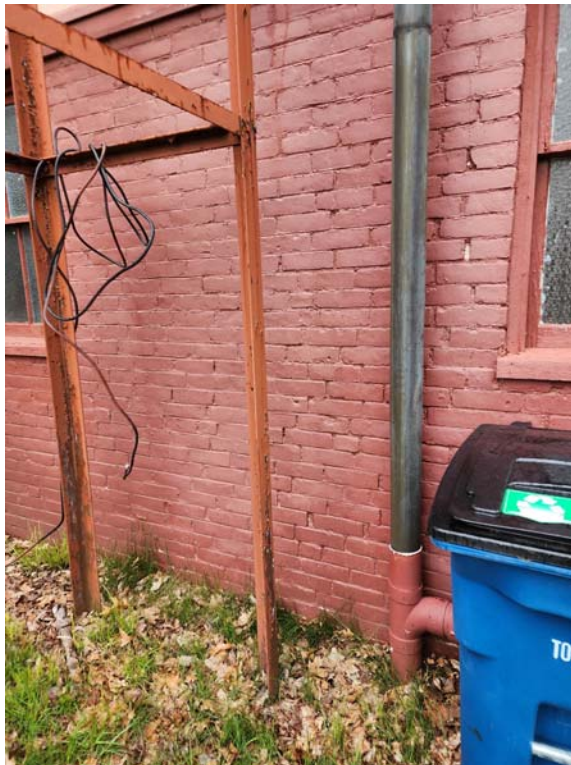
Photograph #21 (Town Hall)
– Damaged Exterior Masonry

Photograph #22 (Town Hall)
– Deteriorated Exterior Masonry Joints

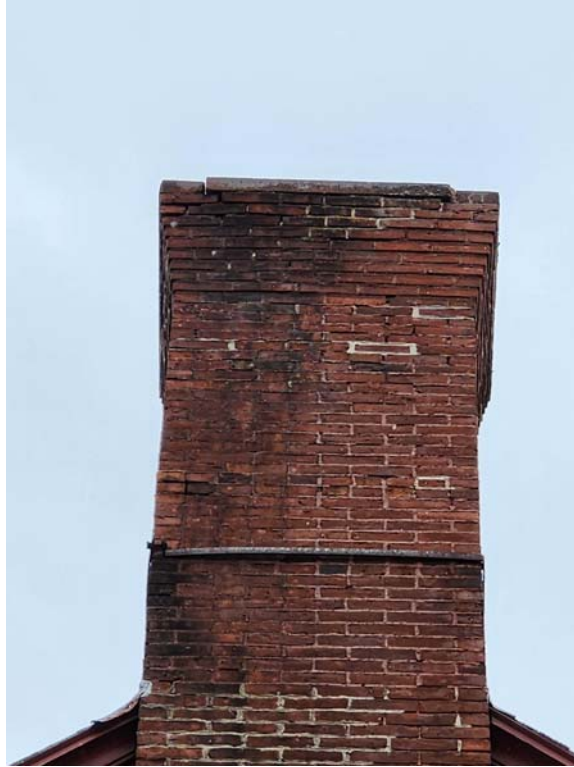
- The masonry on the chimney appears to be in poor condition when viewed from grade (see photograph #23).
- It was stated that one of the timber beams comprising a roof truss previously failed. The failed timber was reinforced with steel plates and diagonal 2x members (see photograph #24).

Photograph #23 (Town Hall)
– Chimney Masonry

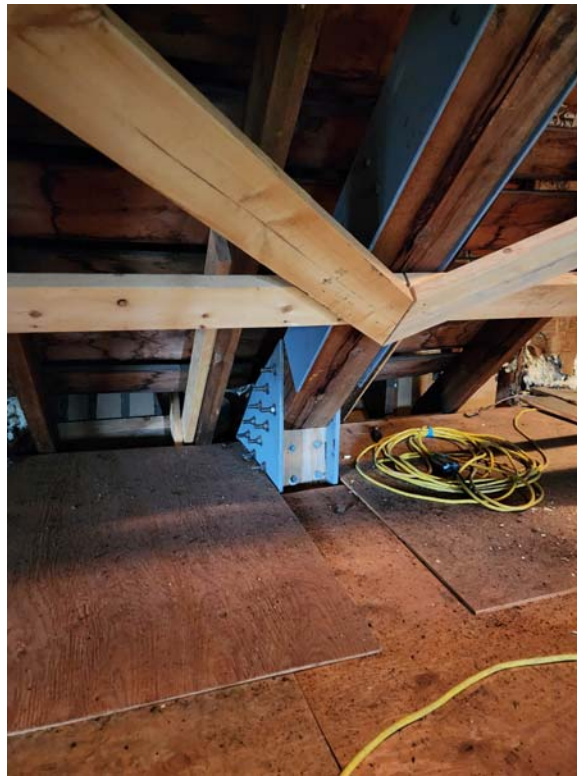
Photograph #24 (Town Hall)
– Reinforced Roof Truss Member

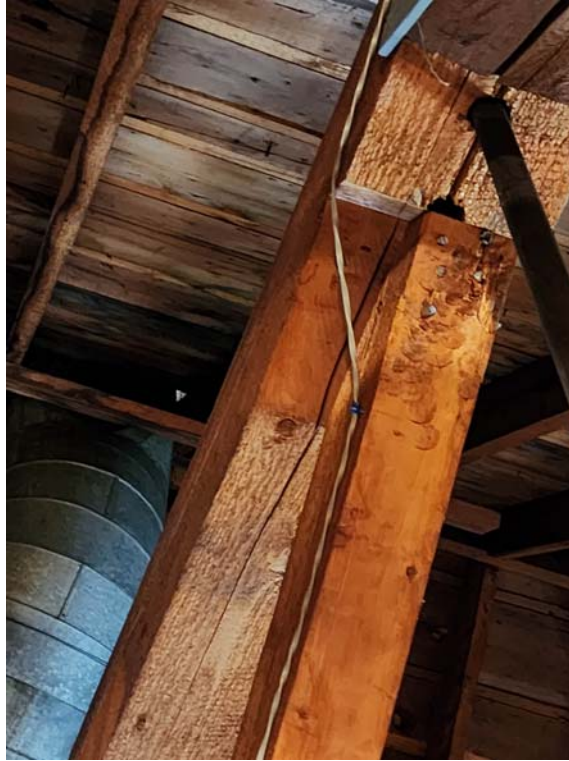
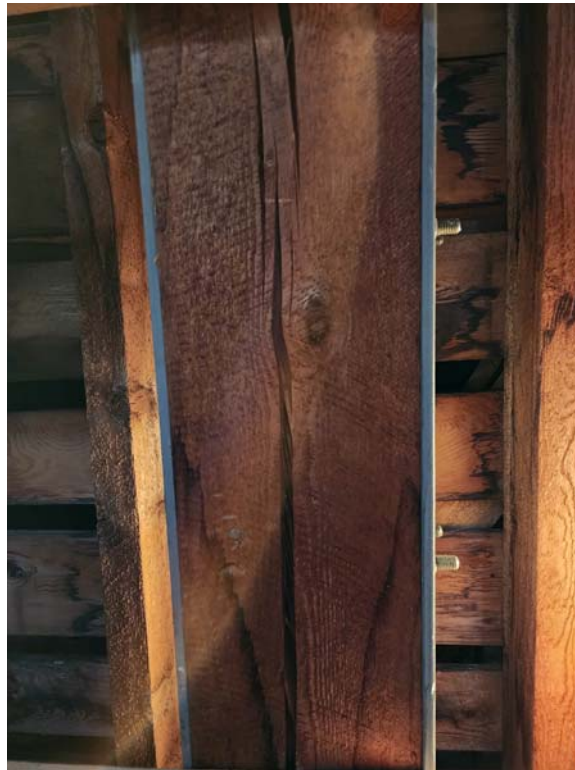
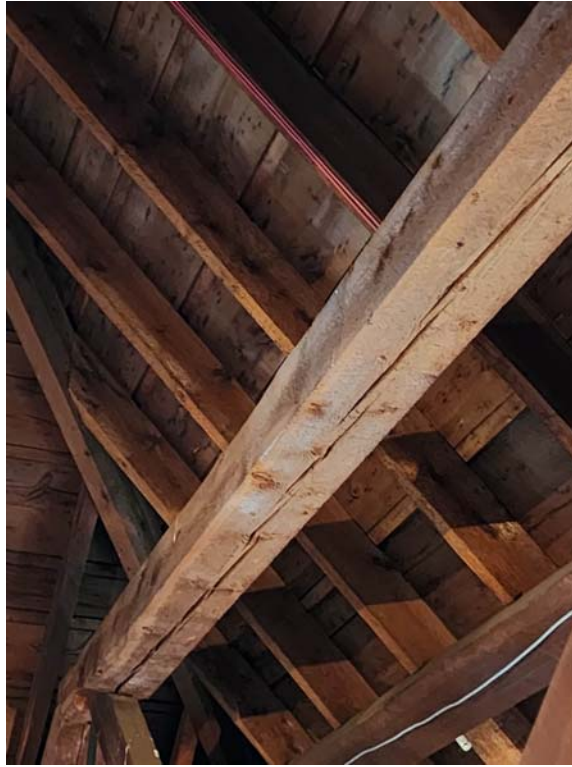
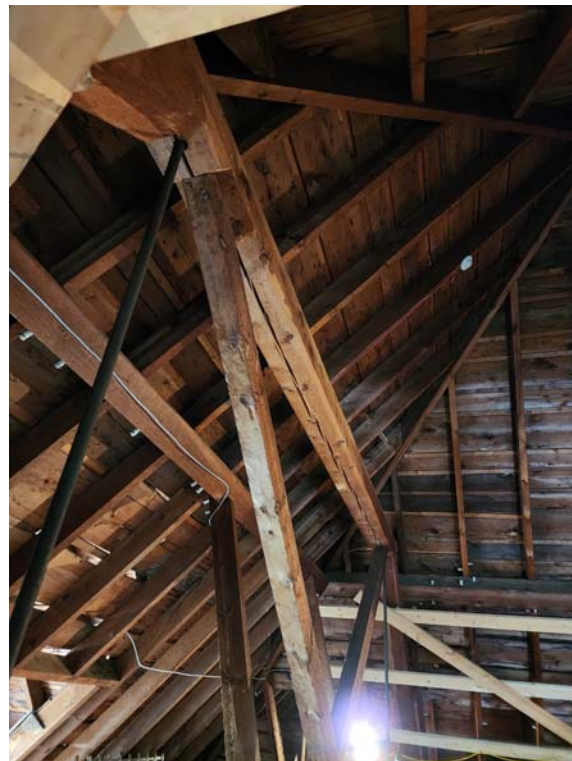
- The timber members comprising the roof trusses are severely split (see photographs #25 through #28).
- There has been a lot of movement within the roof trusses. Large gaps have formed at the member joints (see photographs #29 through #33). Wood shims were installed at some of the joints to fill the gaps (see photograph #34).

Photograph #25 (Town Hall)
– Cracked Truss Member

Photograph #26 (Town Hall)
– Cracked Truss Member

Photograph #27 (Town Hall)
– Cracked Truss Member

Photograph #28 (Town Hall)
– Cracked Truss Member

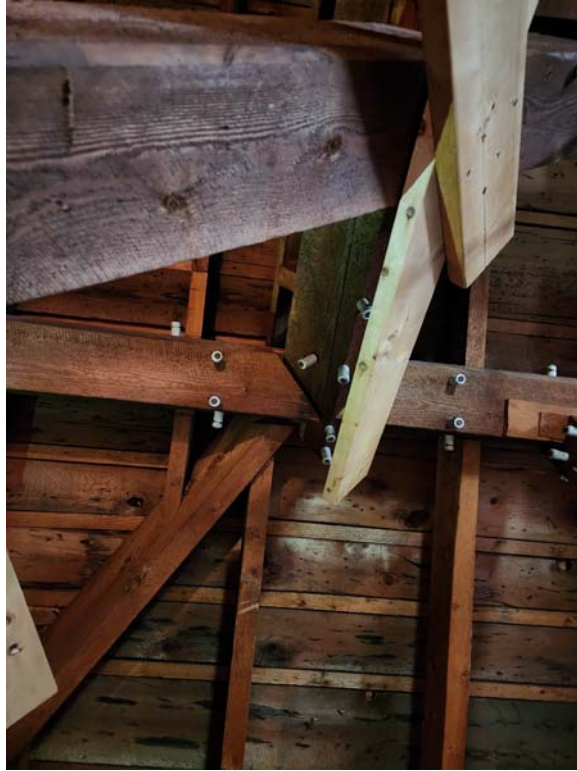
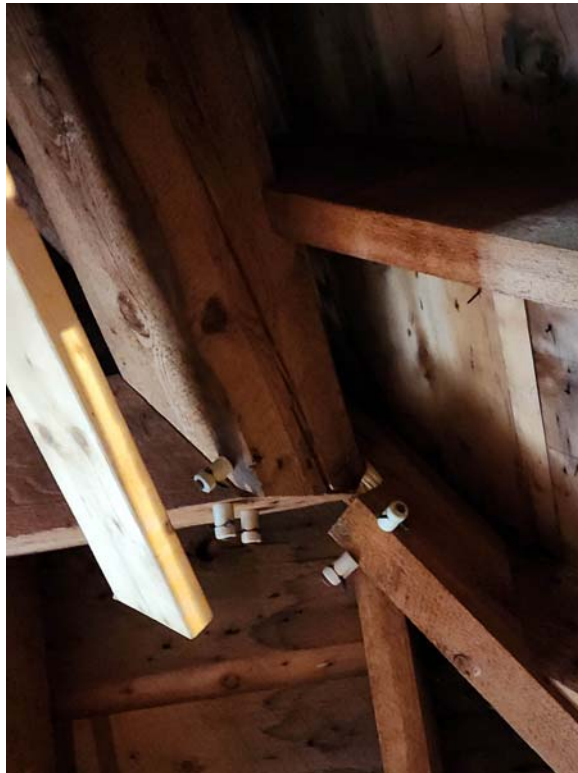
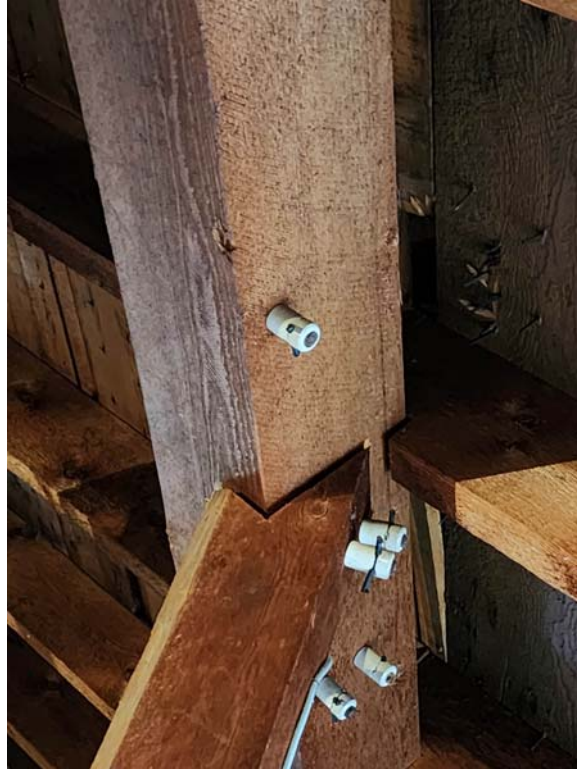
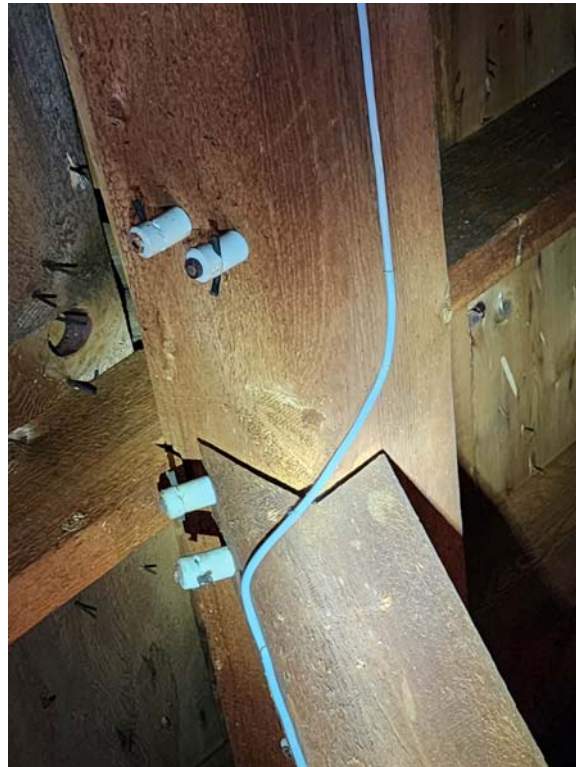
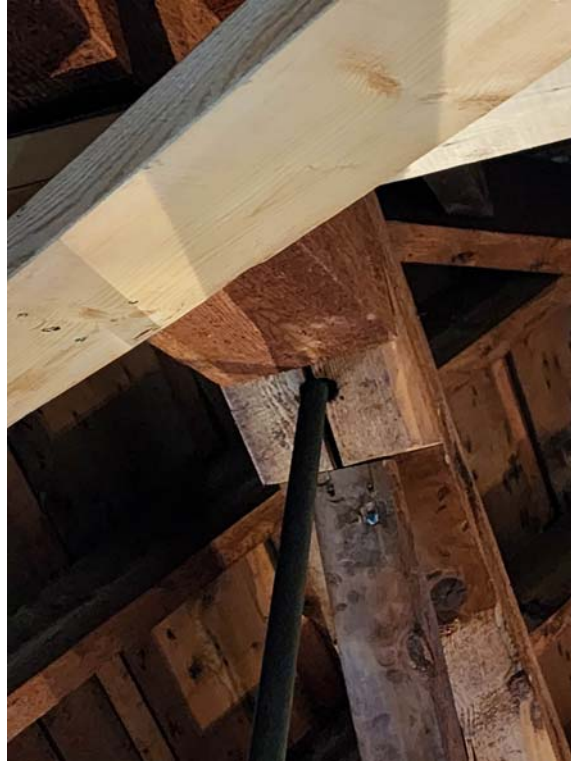
Photograph #29 (Town Hall)
– Gaps at Truss Member Joint

Photograph #30 (Town Hall)
– Gaps at Truss Member Joint

Photograph #31 (Town Hall)
– Gaps at Truss Member Joint

Photograph #32 (Town Hall)
– Gaps at Truss Member Joint

Photograph #33 (Town Hall)
– Gaps at Truss Member Joint

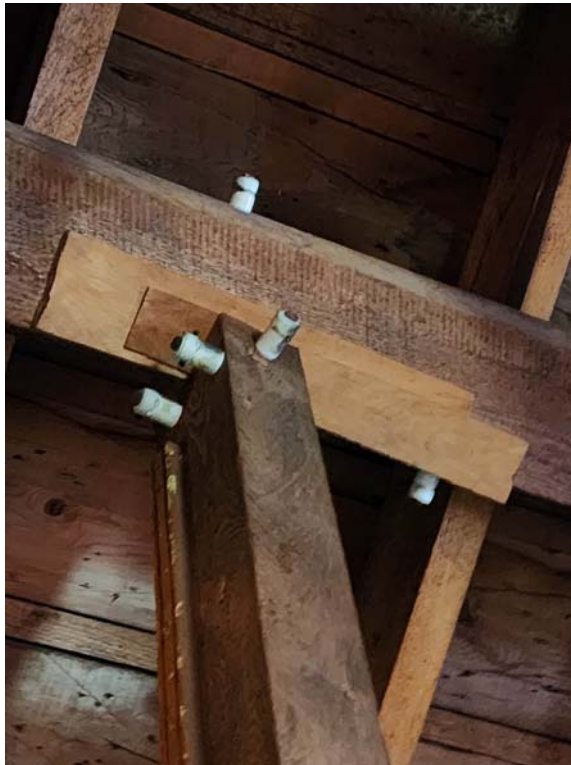
Photograph #34 (Town Hall)
– Wood Shims at Truss Member Joint

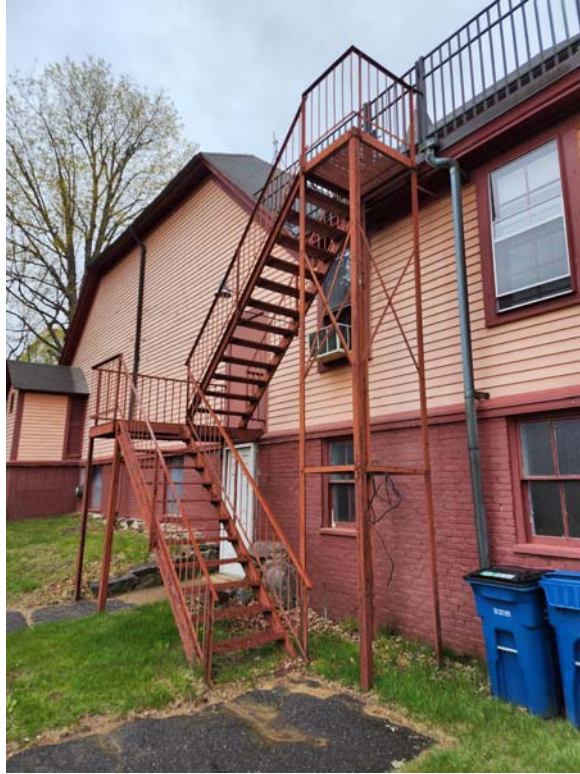
- There are areas of water damage to the roof decking and bell tower floor structure.
- The exterior fire escape along the rear of the building will require reinforcing to comply with the loads and dimensions specified in the building code (see photograph #35).
- The exterior wall along the front right side of the building when viewed from Main Street appears to lean inward (see photograph #36).

Photograph #35 (Town Hall)
– Exterior Fire Escape

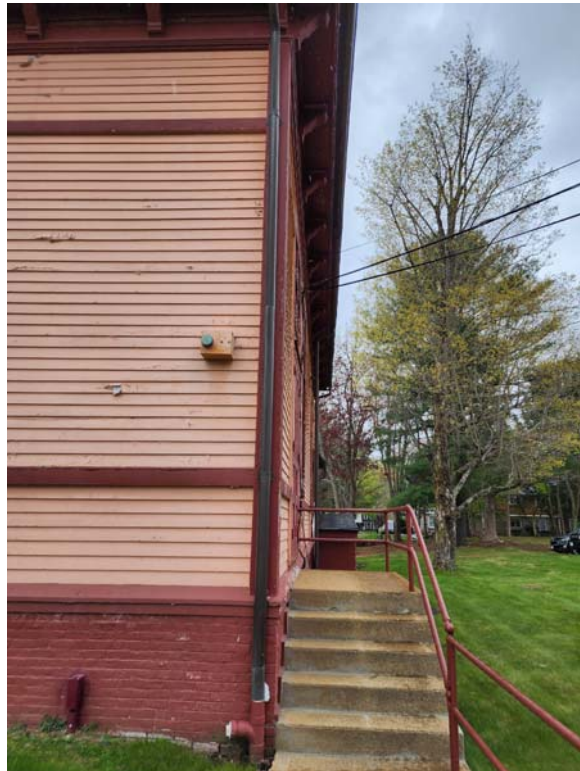
Photograph #36 (Town Hall)
– Leaning Exterior Side Wall

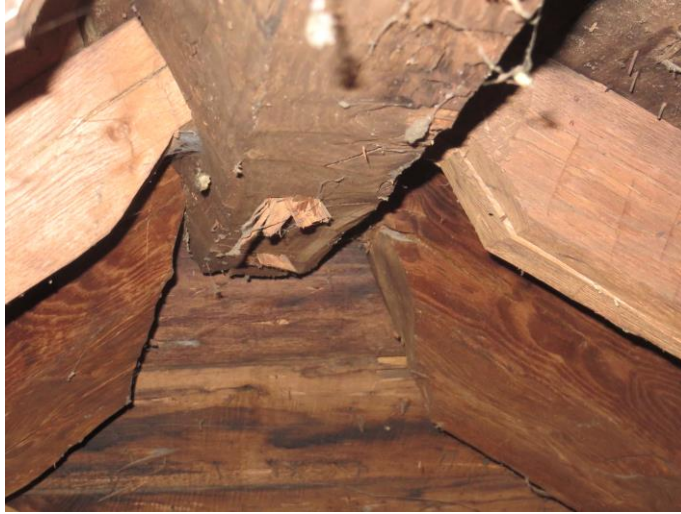
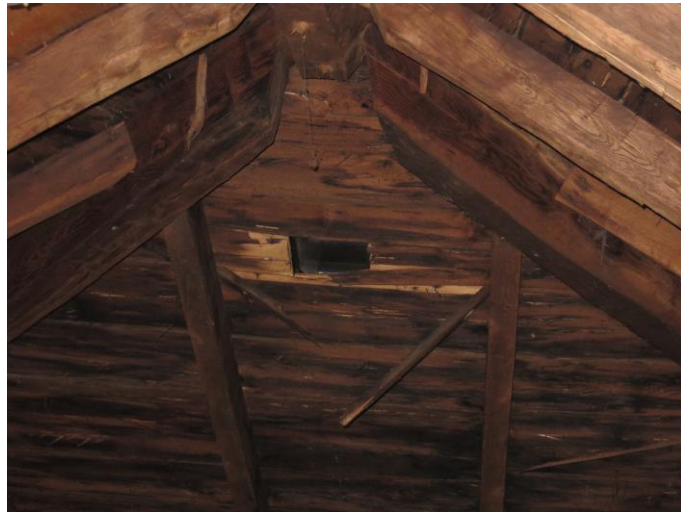
1. The roof for the original building is a wood framed hip roof structure. The roof rafters are 4" by 4" members that are spaced at approximately 2'-6" on center. The roof rafter and hip beam connections to the ridge beam are mortise and tenon joints (see photograph #1). The hip beams have large cracks at the tenon ends. At each end of the roof, the wood planking is severely cracked around the existing roof vent openings (see photograph #2).

Photograph #1 – Existing Roof Framing (Original Building)

Photograph #2 – Cracked Roof Sheathing

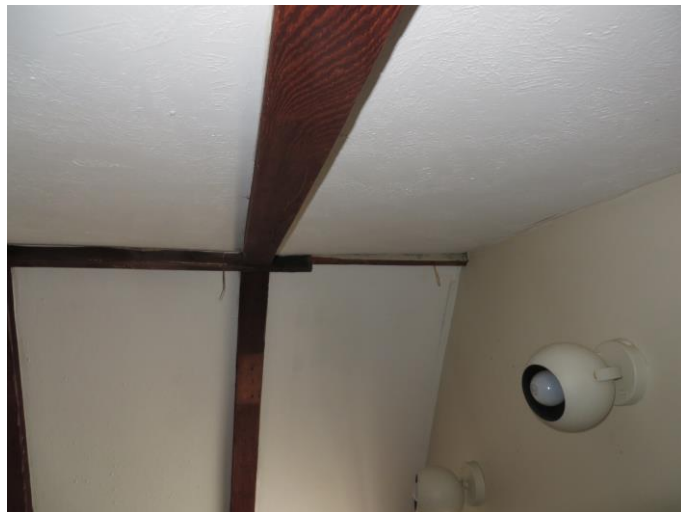
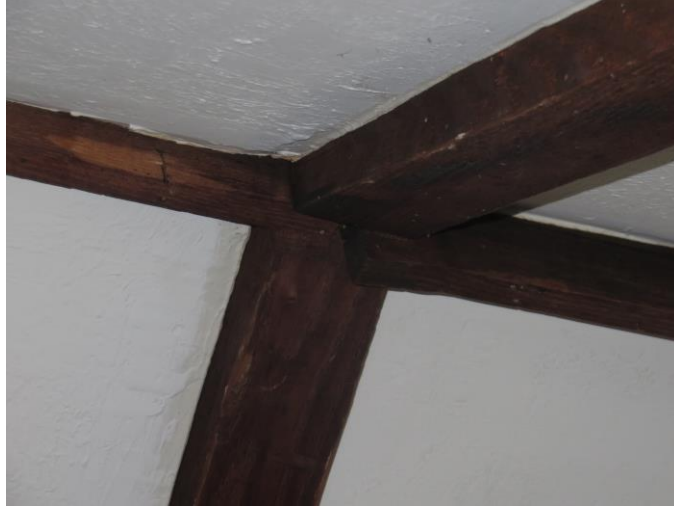
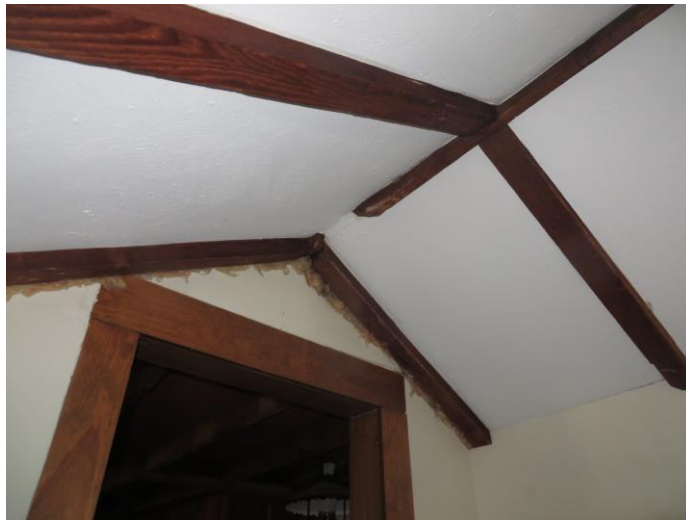
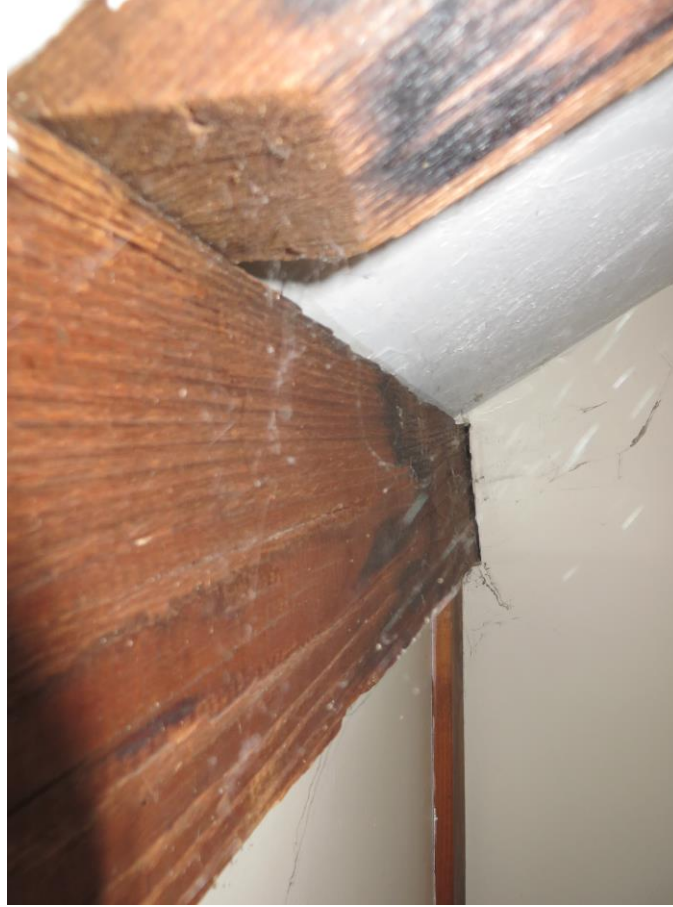
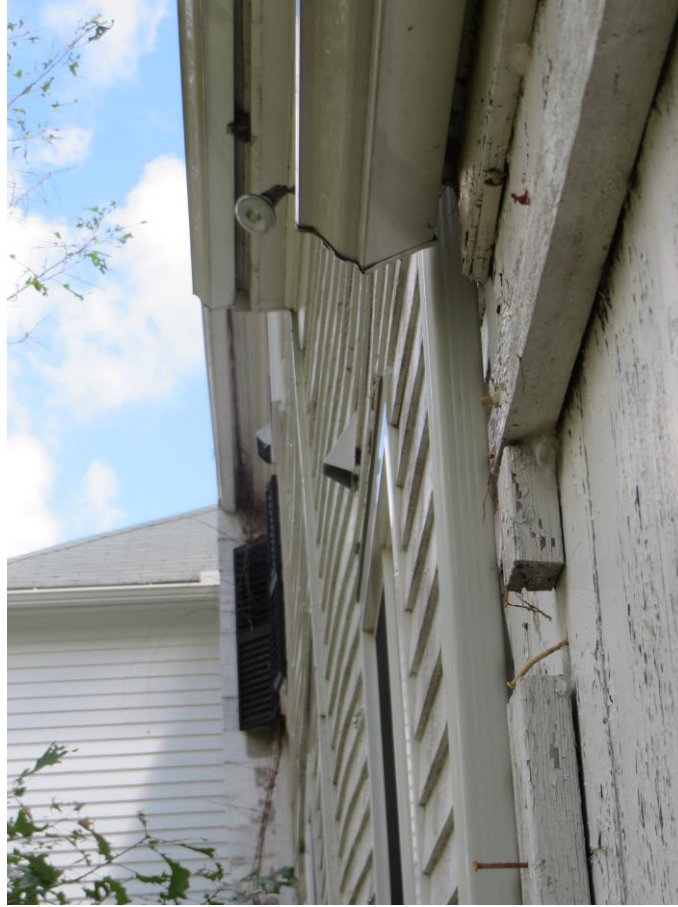
2. The wood framed roof above the "Storage #2" room is comprised of 2-3/4" by 8" (assumed) rafters spaced at approximately 2'-1 1/2" on center. The rafters span from a 6" deep wood beam along the exterior walls to a single ridge member. The ridge member appears to be scabbed together with multiples wood pieces (see photographs #3 through #5). The 6" deep wood beam along the exterior walls has rotated (see photograph #6). The exterior walls in the "Storage #2" room are approximately 2" out of plumb (see photograph #6.1). The beam rotation and the

- wall being out of plumb is most likely due to the outward thrust of the roof rafters due to the lack of a true ridge beam.
3. It is unknown whether the ceiling framing in the “Kitchen” room is a decorative finish or whether it is the framing for the attic above. Access to the attic space was not accessible. The framing is comprised of 2” by 7” wood joists spaced at 2’-0” on center that are supported by 8” wide by 7” deep wood beams. There is a noticeable downward slope in the framing to the center beam line. The joist to beam connections are mortise and tenon joints, and are pulling apart (see photograph #7). The mortise and tenon beam to beam connections are also pulling apart (see photograph #8). Some of the joists are irregular along their top surface and provide minimal support for the planking (see photograph #9).

Photograph #3 – “Storage” Ridge Member

Photograph #4 – “Storage” Ridge Member

Photograph #5 – “Storage” Ridge Member

Photograph #6 – “Storage” Perimeter Roof Beam

Photograph #6.1 – Exterior Bowed Wall at “Storage 1”

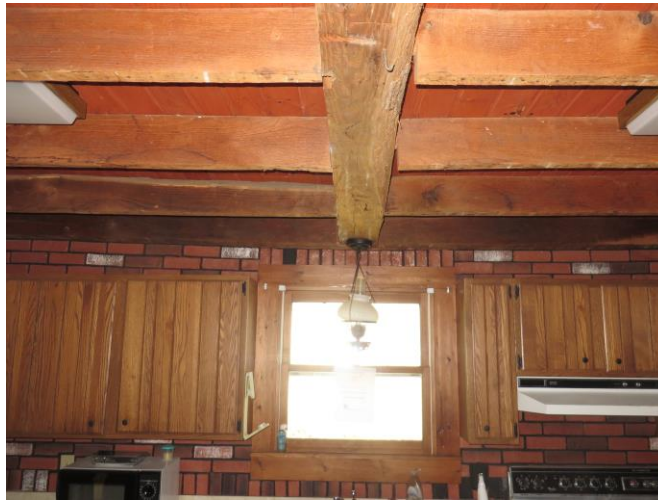
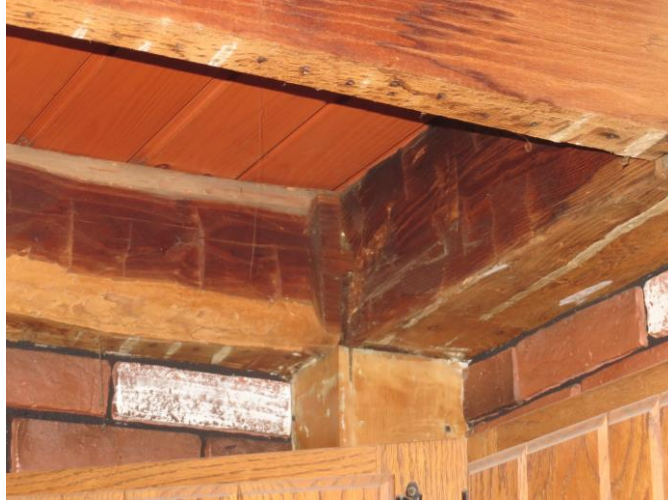
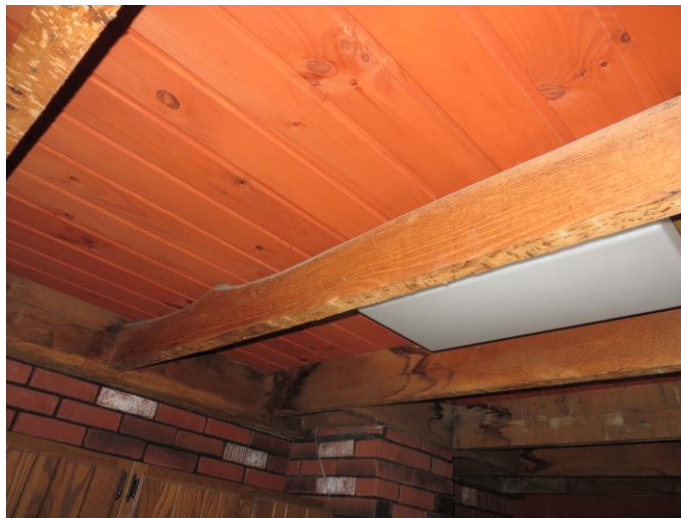
Photograph #7 – “Kitchen” Ceiling/Attic Framing

Photograph #8 – “Kitchen” Beam-Beam Connection

Photograph #9 – “Kitchen” Ceiling/Attic Joist
