JSE JOHNSON STRUCTURAL ENGINEERING, INC.

Re: Structural Inspection
Brimfield Town Hall Annex & Town Hall Buildings

Re: Structural Review
Town Hall Annex
Brimfield, MA

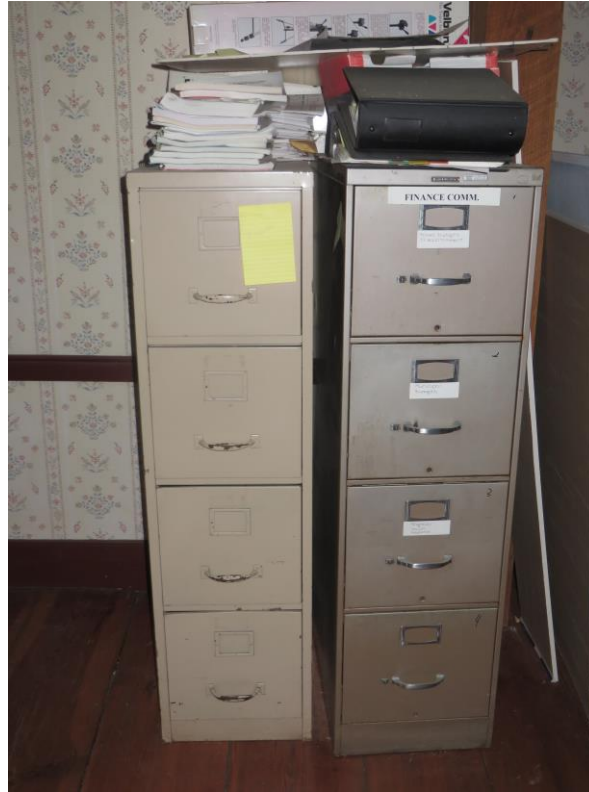
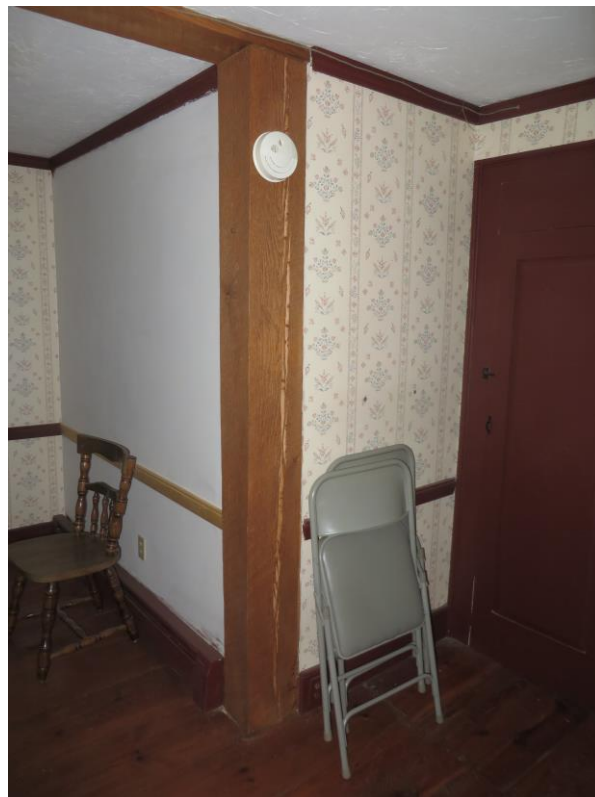
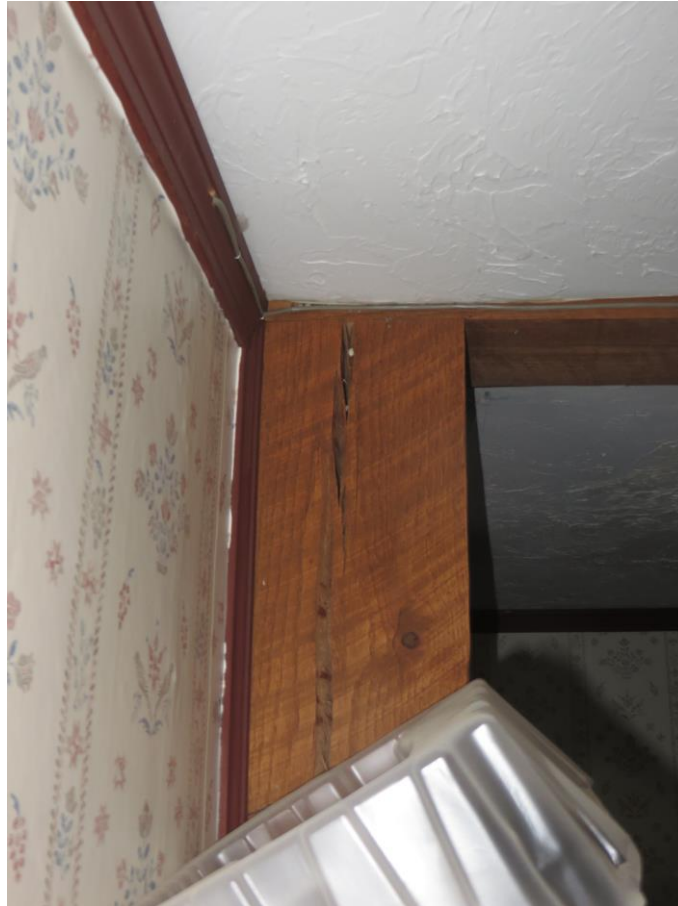
4. The second floor in the “Storage #1” room is severely sloped (see photograph #10, which shows the varying gap width between two adjacent filing cabinets due to the floor slope). There is a high point in the second floor along the two exterior walls and along an assumed center beam. The low points are at the approximate middle of the “Storage #1” room and next to the wall between the “Storage #1” room and the “Toilet & Shower #2” room. The second floor structure was not accessible due to a hard ceiling. However, the exposed timber columns in “Storage #1” have large vertical cracks (see photograph #10.1 and #10.2).

Photograph # 10 – “Storage 1” Sloped Floor

Photograph #10.1 – “Storage 1” Cracked Wood Column

Photograph #10.2 – “Storage 1” Cracked Wood Column

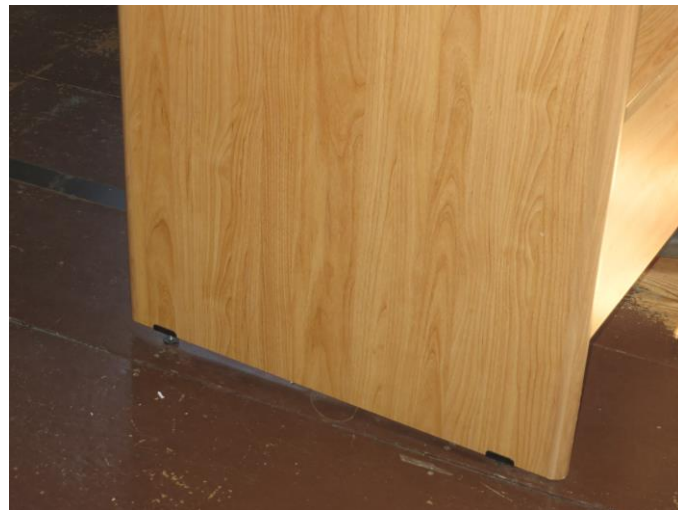
5. The second floor in the “Treasurer” office is severely sloped (see photograph #11, which shows the varying gap between the bottom of the desk and the flooring). The floor slopes downward from the exterior wall to the interior corridor wall. The second floor structure was not accessible due to a hard ceiling.

Photograph #11 – “Treasurer” Sloped Floor

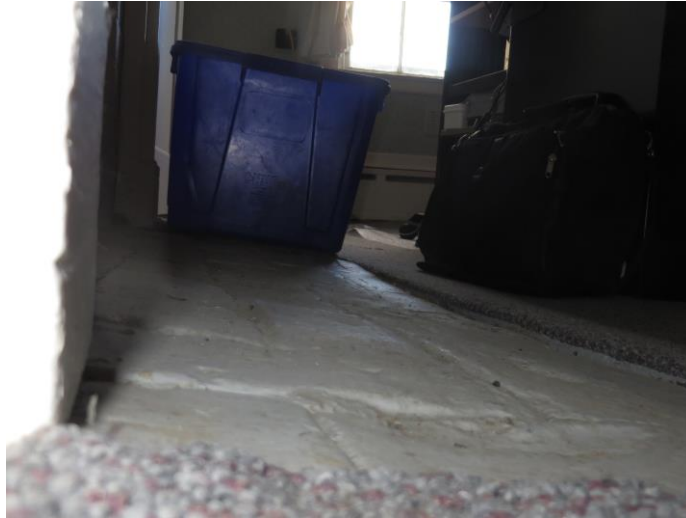
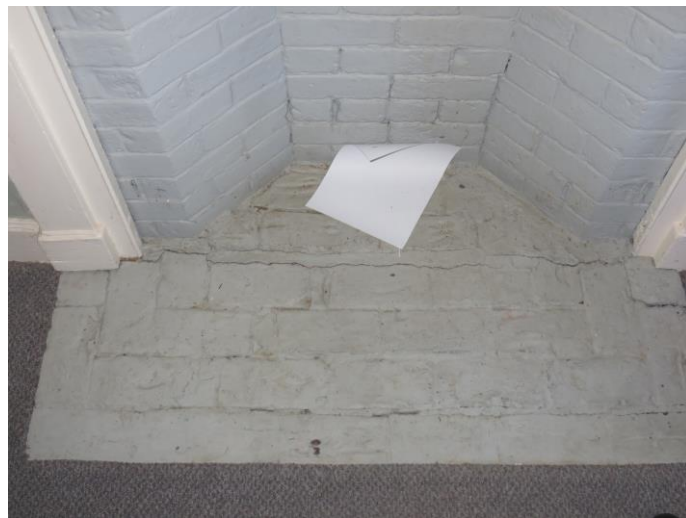
6. The second floor in the “Conservation” office is severely sloped. The floor slopes downward from the exterior wall to the interior corridor wall, and also slopes downward from the masonry fireplace hearth to the interior of the room (see photograph #12). It appears that the masonry hearth has cracked due to the floor slope (see photograph #13).

Photograph #12 – “Conservation” Sloped Floor

Photograph #13 – “Conservation” Cracked Masonry Hearth

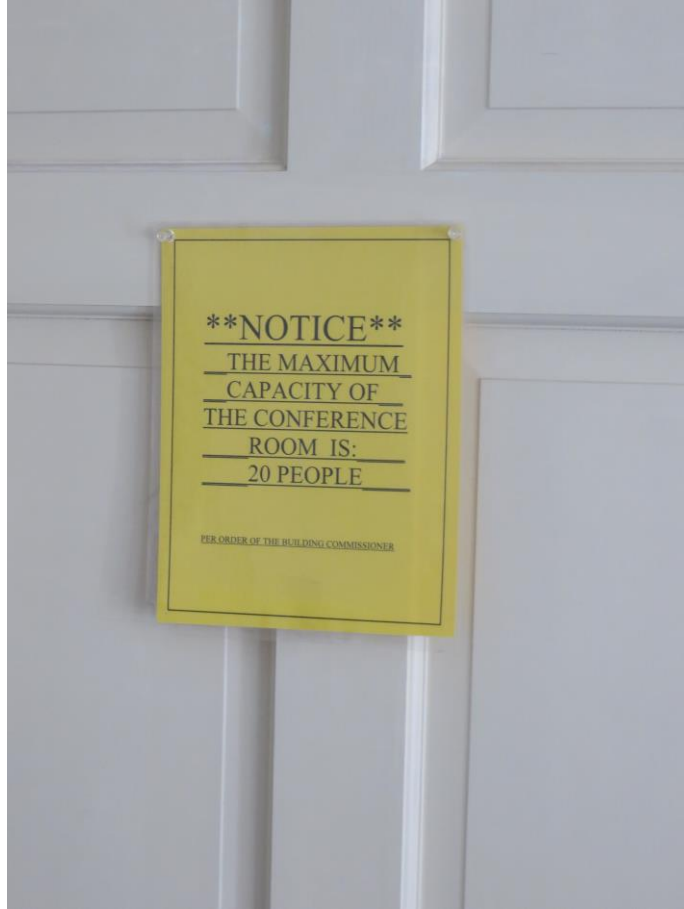
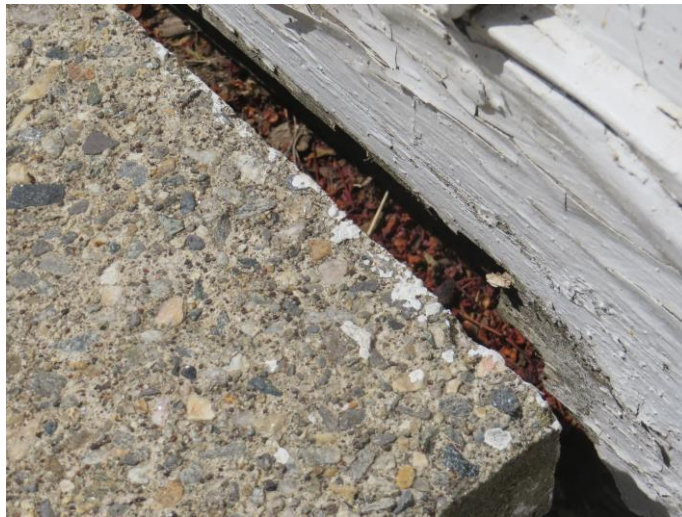
7. The main stairs between the first and second floors have a noticeable pitch towards the hallway wall.
 8. There is a sign posted on the door limiting the number of people in the “Meeting Room” (see photograph #14). The perimeter first floor beam below the exterior door in the “Meeting Room” is rotted (see photograph #14.1).

Photograph #14 – “Meeting Room” Sign

Photograph #14.1 – Rotted Sill at “Meeting” Exterior Door

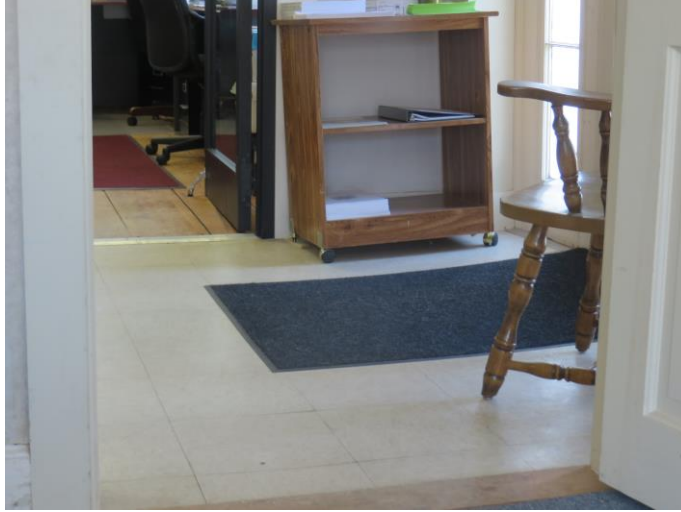
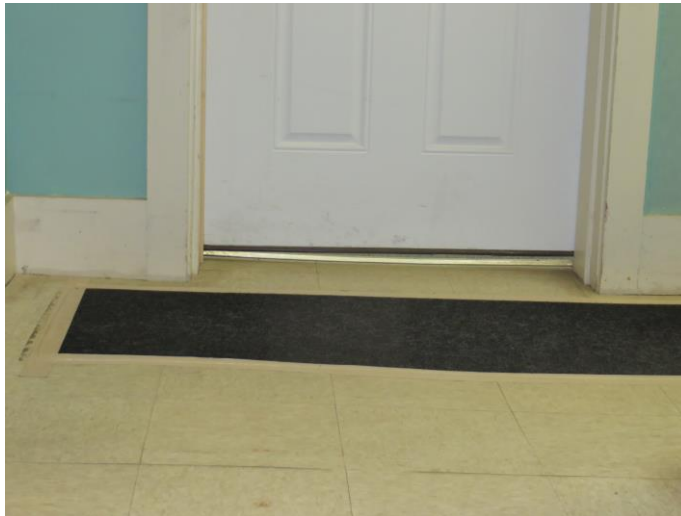
9. The first floor corridor is severely sloped downward at the front door (see photograph #15).
 10. The first floor corridor in front of the Assessor’s Office is sloped (see photograph #16). When accessed through an opening to the crawl space in the basement, the existing floor framing in this area is comprised of 1-1/2” by 6” joists spaced at approximately 1’-8” on center. A structural analysis was performed, which indicates the floor joists have minimal live load capacity (approximately 30 pounds per square foot).

Photograph #15 – First Floor Hallway Slope

Photograph #16 – Sloped Hallway in front of Assessor's Office

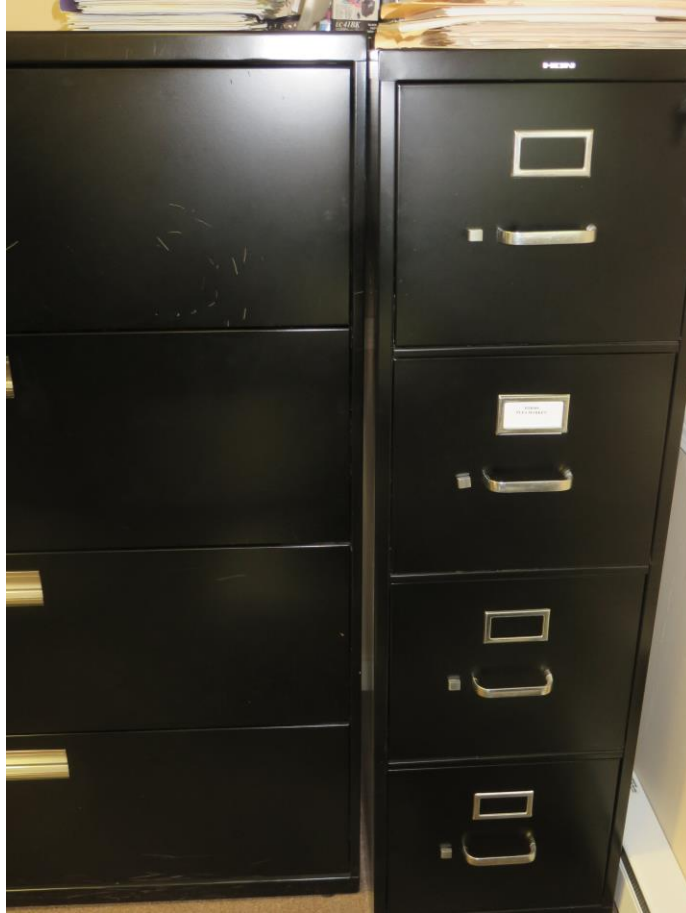
11. The first floor in the “Board of Health” room slopes downward from exterior wall to the interior corridor wall (see photograph #17, which shows the varying gap width between two adjacent filing cabinets due to the floor slope). The first floor framing below at this location was not accessible at the time of the site visit.

Photograph #17 – “Board of Health” Sloped Floor

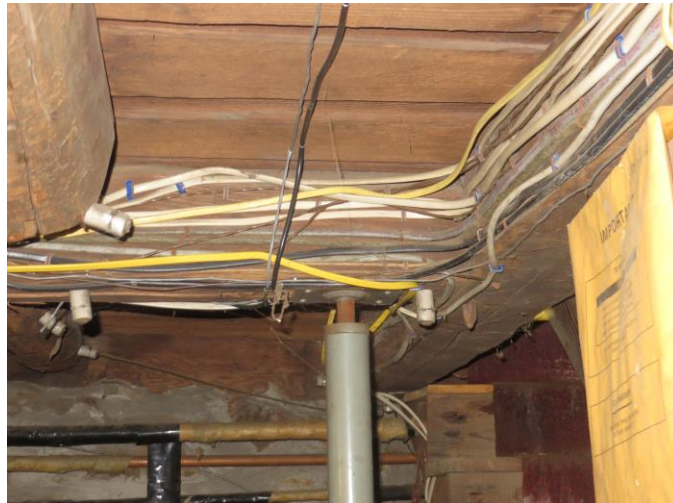
13. The barn is in severe disrepair and should not be accessed.
14. The first floor framing for the original building is comprised of round logs of various sizes that are supported by 7-1/2" wide by 6-3/4" deep wood beams. The first floor framing is severely cracked (see photograph #18). Based on how the upper floors sloped in the original building, it is likely that the first floor corridor walls, which align with the two main first floor beams lines, are bearing walls for the second floor framing. A structural analysis was not performed on the round logs due to their irregular shape (the top of the logs were plained flat to support the floor planking).

Photograph #18 – First Floor Framing (Cracked)

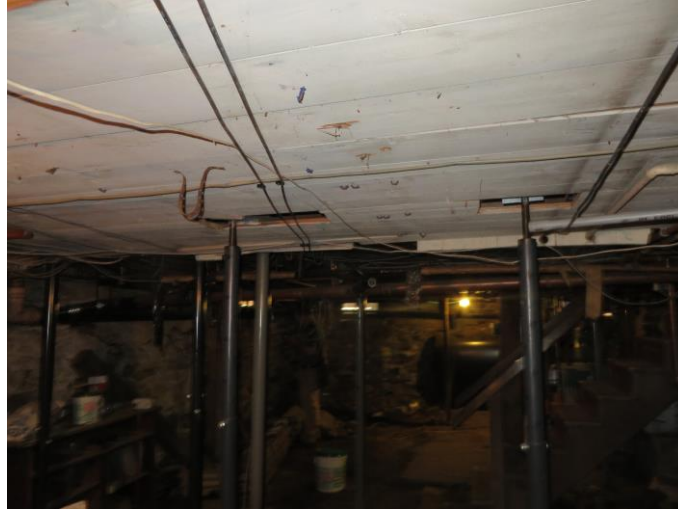
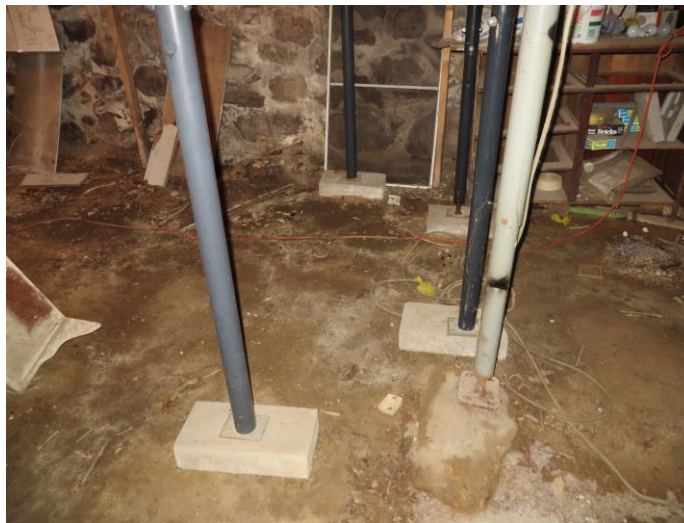
15. Temporary screw type shoring jacks were previously installed throughout to support the first floor framing (see photograph #18.1). Some of the shoring jacks were installed along the length of various joists and beams, and some were installed below beam connections. The shoring jacks bear on cinder blocks and stones (see photograph #19). Note that temporary screw type shoring jacks are not meant to be used as permanent supports.

Photograph #18.1 – First Floor Shoring Jacks

Photograph #19 – First Floor Shoring Jacks

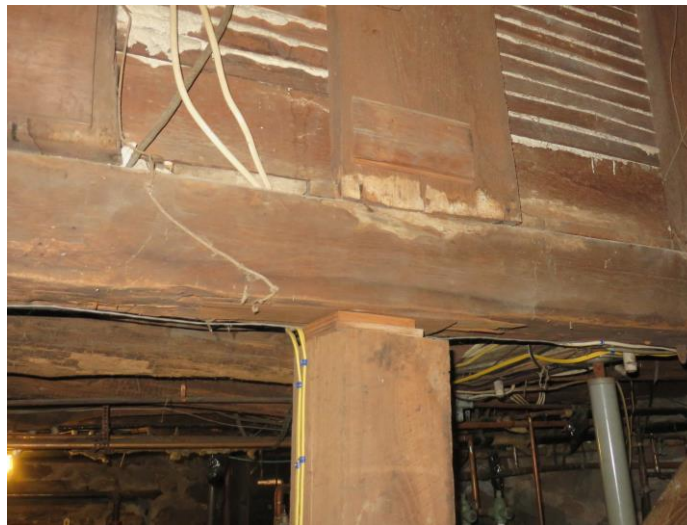
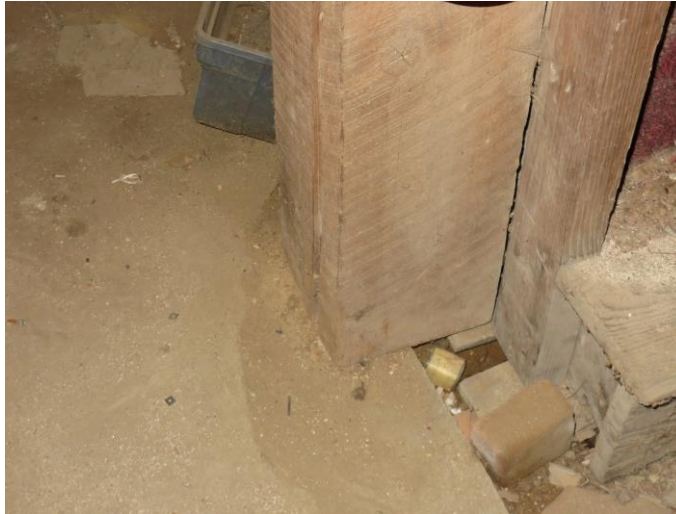
16. Wood shims were previously installed between an existing wood beam to wood column connection (see photograph #20). The wood column is partially sitting on a concrete slab and a portion of the column is unsupported (see photograph #21). The concrete slab has cracked around where the post bears on the slab.

Photograph #20 – First Floor Beam-Column Connection

Photograph #21 -Cracked Wood Column and Concrete Slab

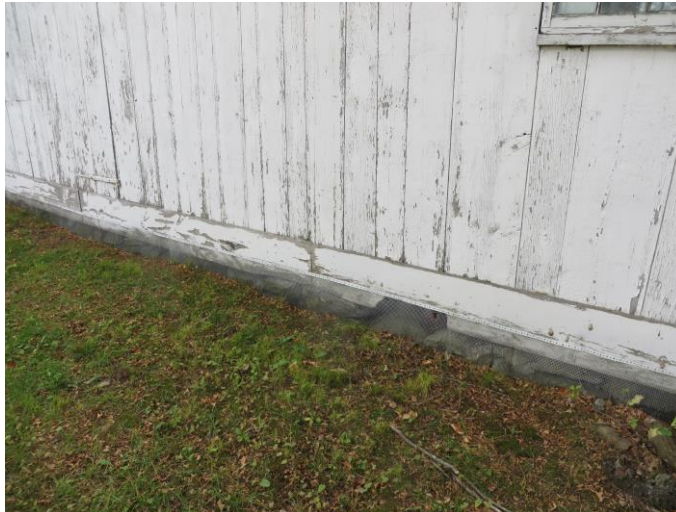
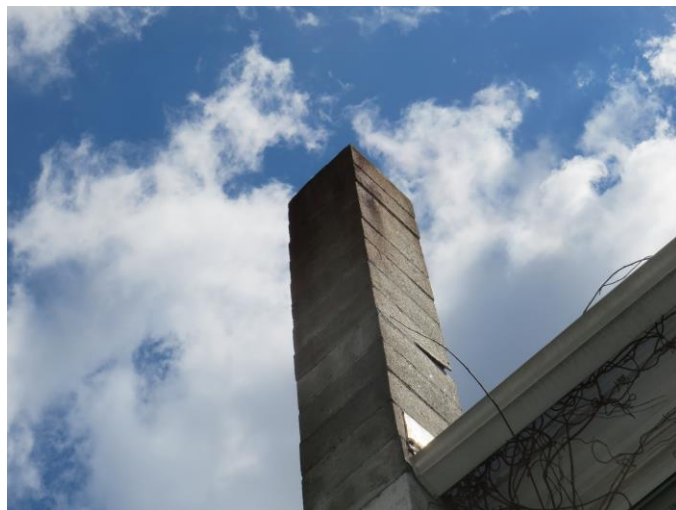
17. Portions of the field stone foundation below the "Storage" room is missing (see photograph #22).
18. The chimney is deteriorating (see photograph #23).

Photograph #22 – Missing “Storage” Foundation

Photograph #23 – Chimney

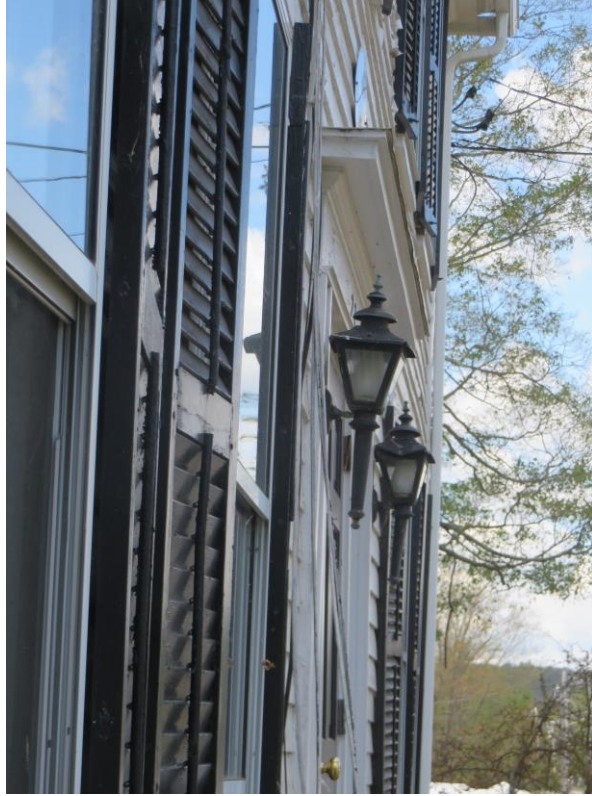
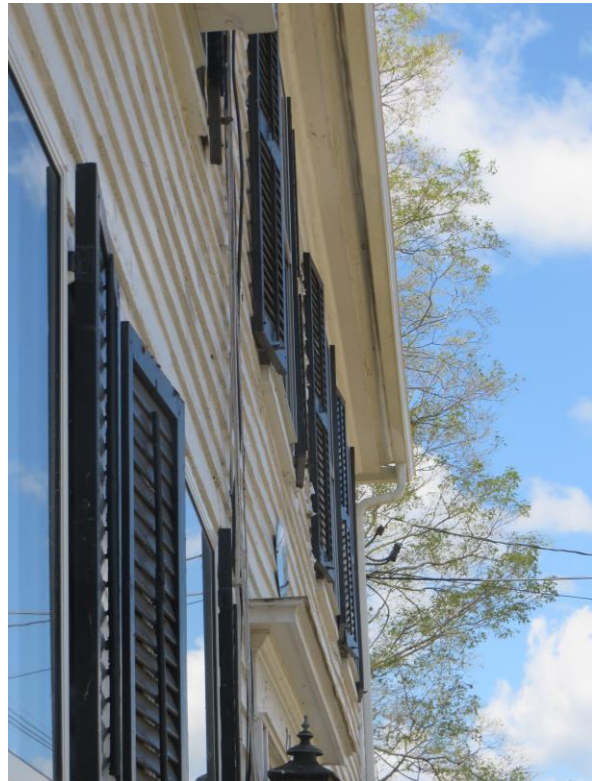
19. There is a large bow in the front exterior wall adjacent to the front door (see photograph #24 and #25).

Photograph #24 – Bowed Front Exterior Wall

Photograph #25 – Bowed Front Exterior Wall
