TOWN OF BRIMFIELD

Re: Structural Condition Survey
Town Hall Annex
Brimfield, Massachusetts

Re: Structural Review
Town Hall Annex
Brimfield, MA

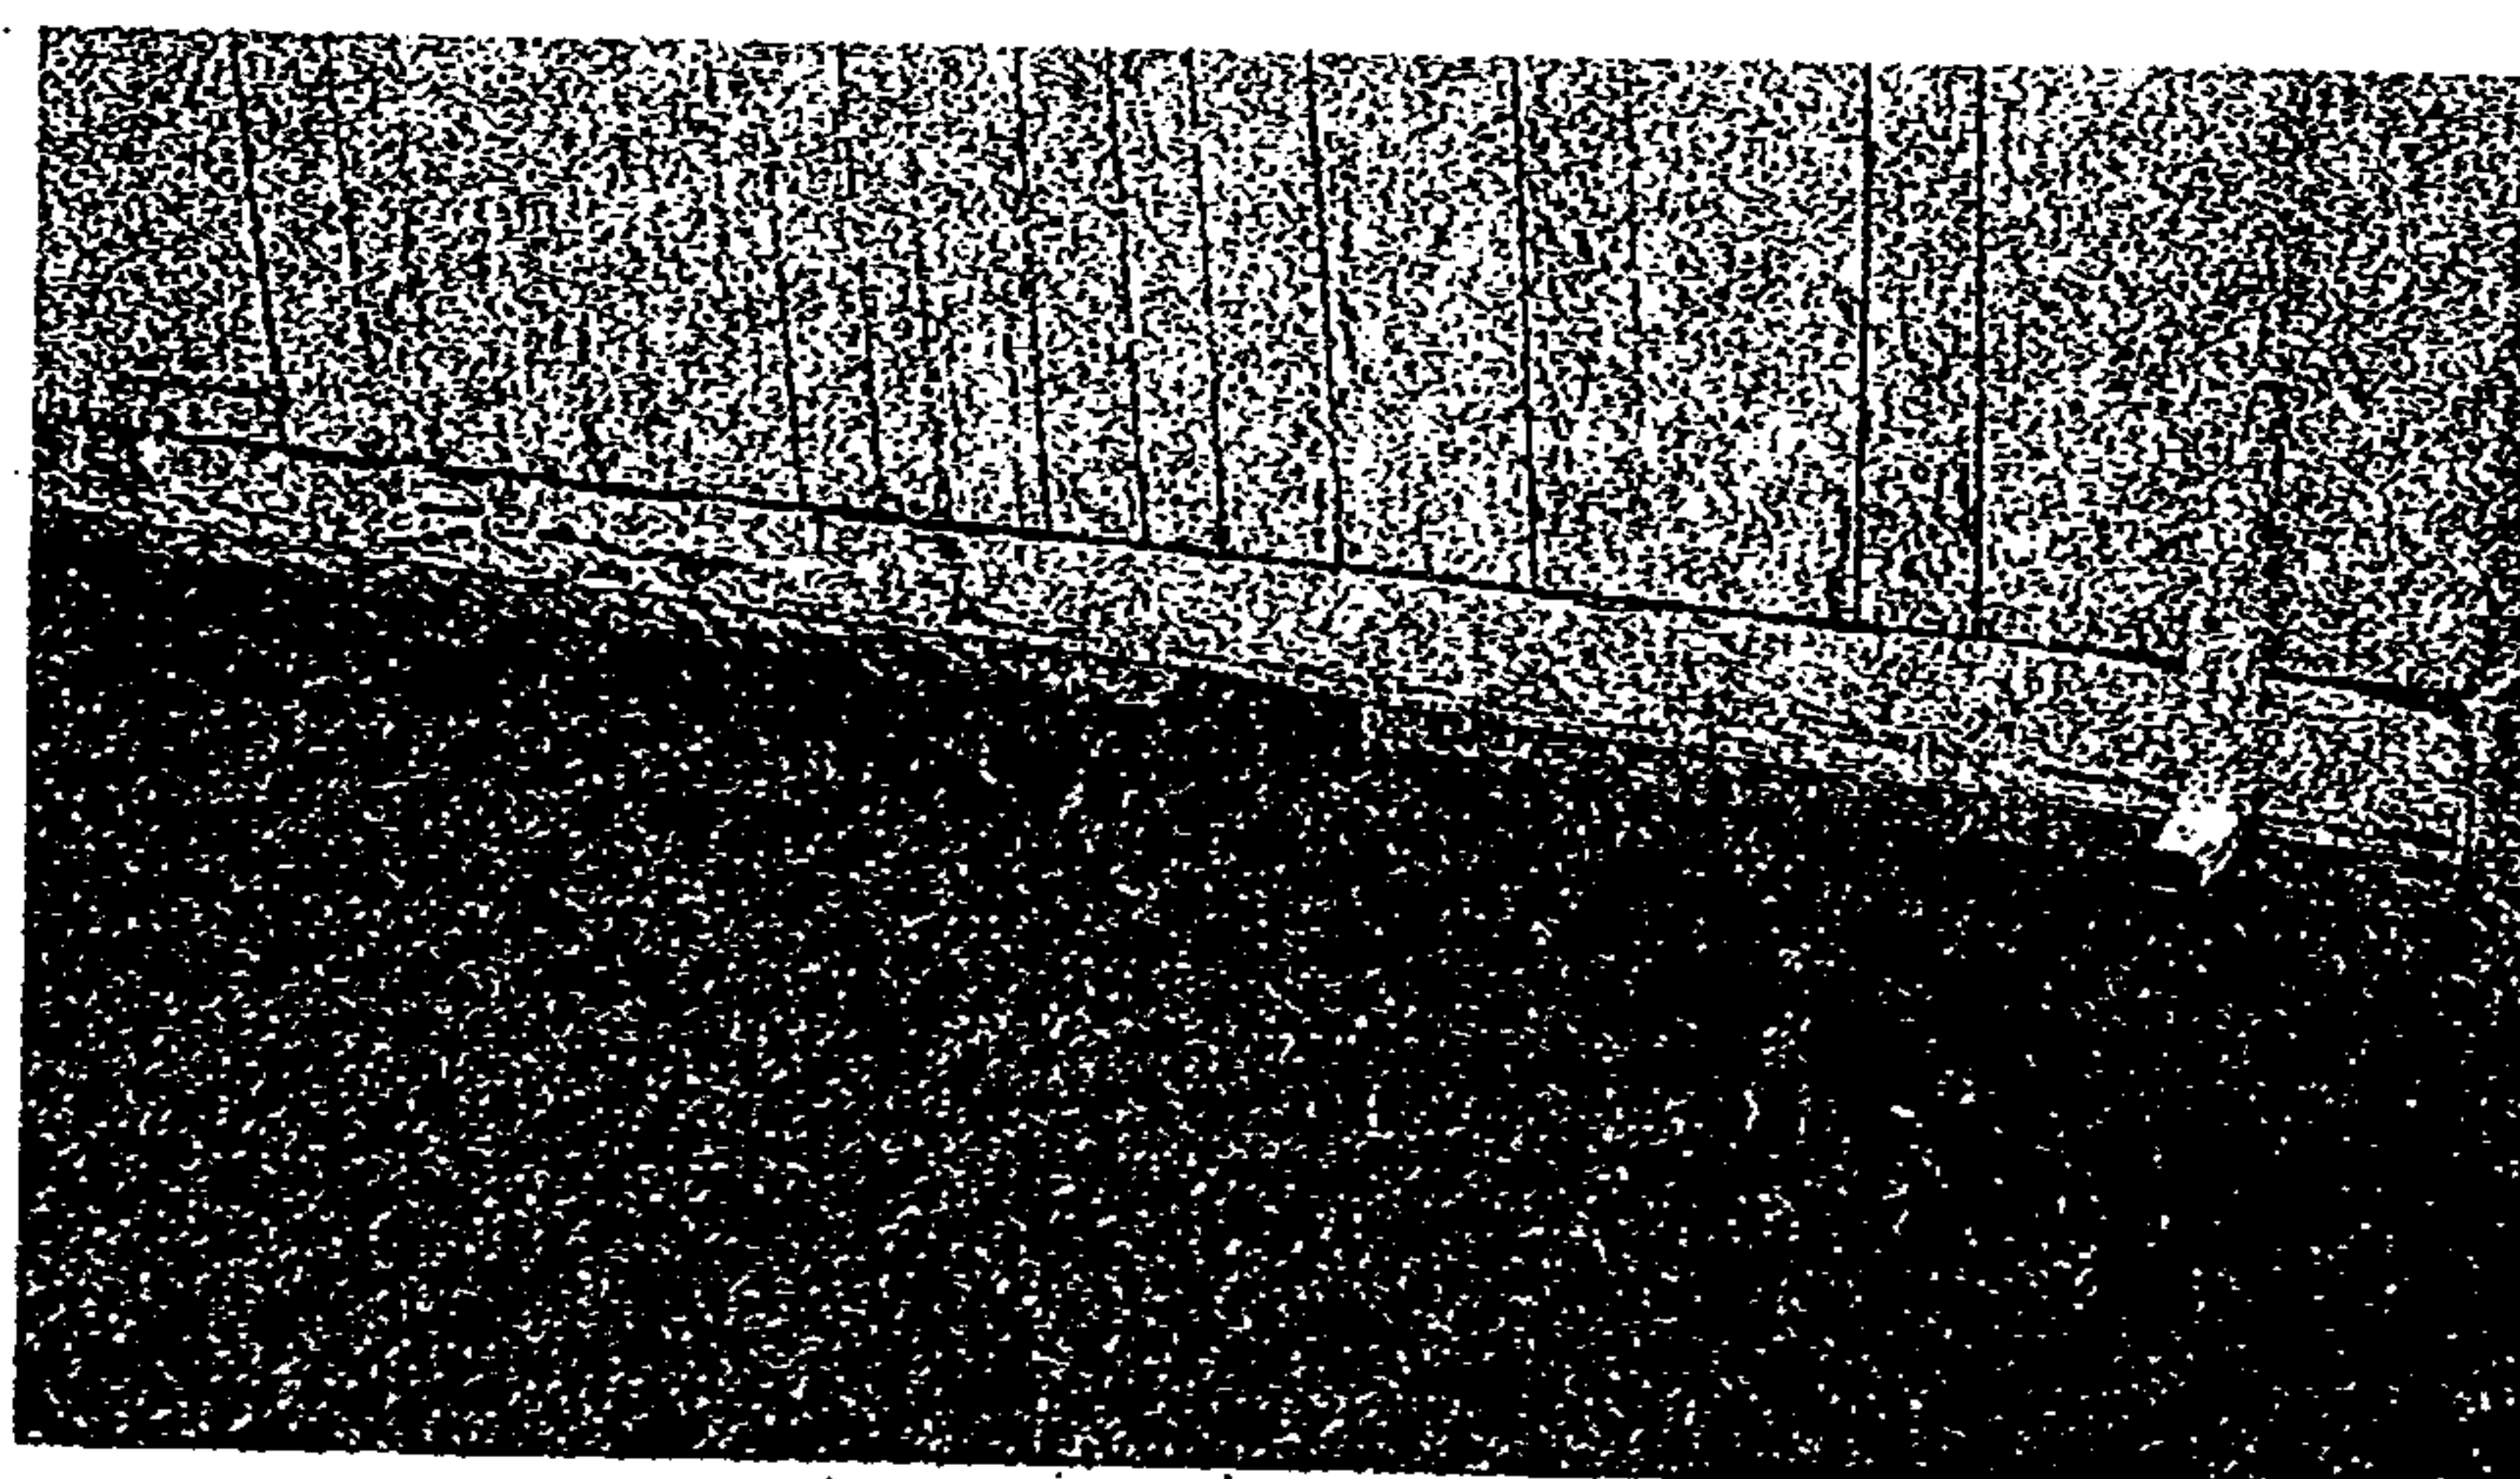
6. The one story connector between the main building and the barn is in very poor condition. It appears that the foundations do not extend to the minimum frost depth of four (4'-0") feet below grade, and significant rot has occurred in the sill plate at the top of the foundation wall. In addition, the wall siding is in poor condition with evident cracking and joint separation.

Deteriorated Connector Foundations and Sill

- b. Given the condition of the foundations for the one story connector between the barn and the main building, it is our recommendation that this structure also be demolished. Continued use as storage is permissible in the interim, if the condition of the structure is regularly monitored.

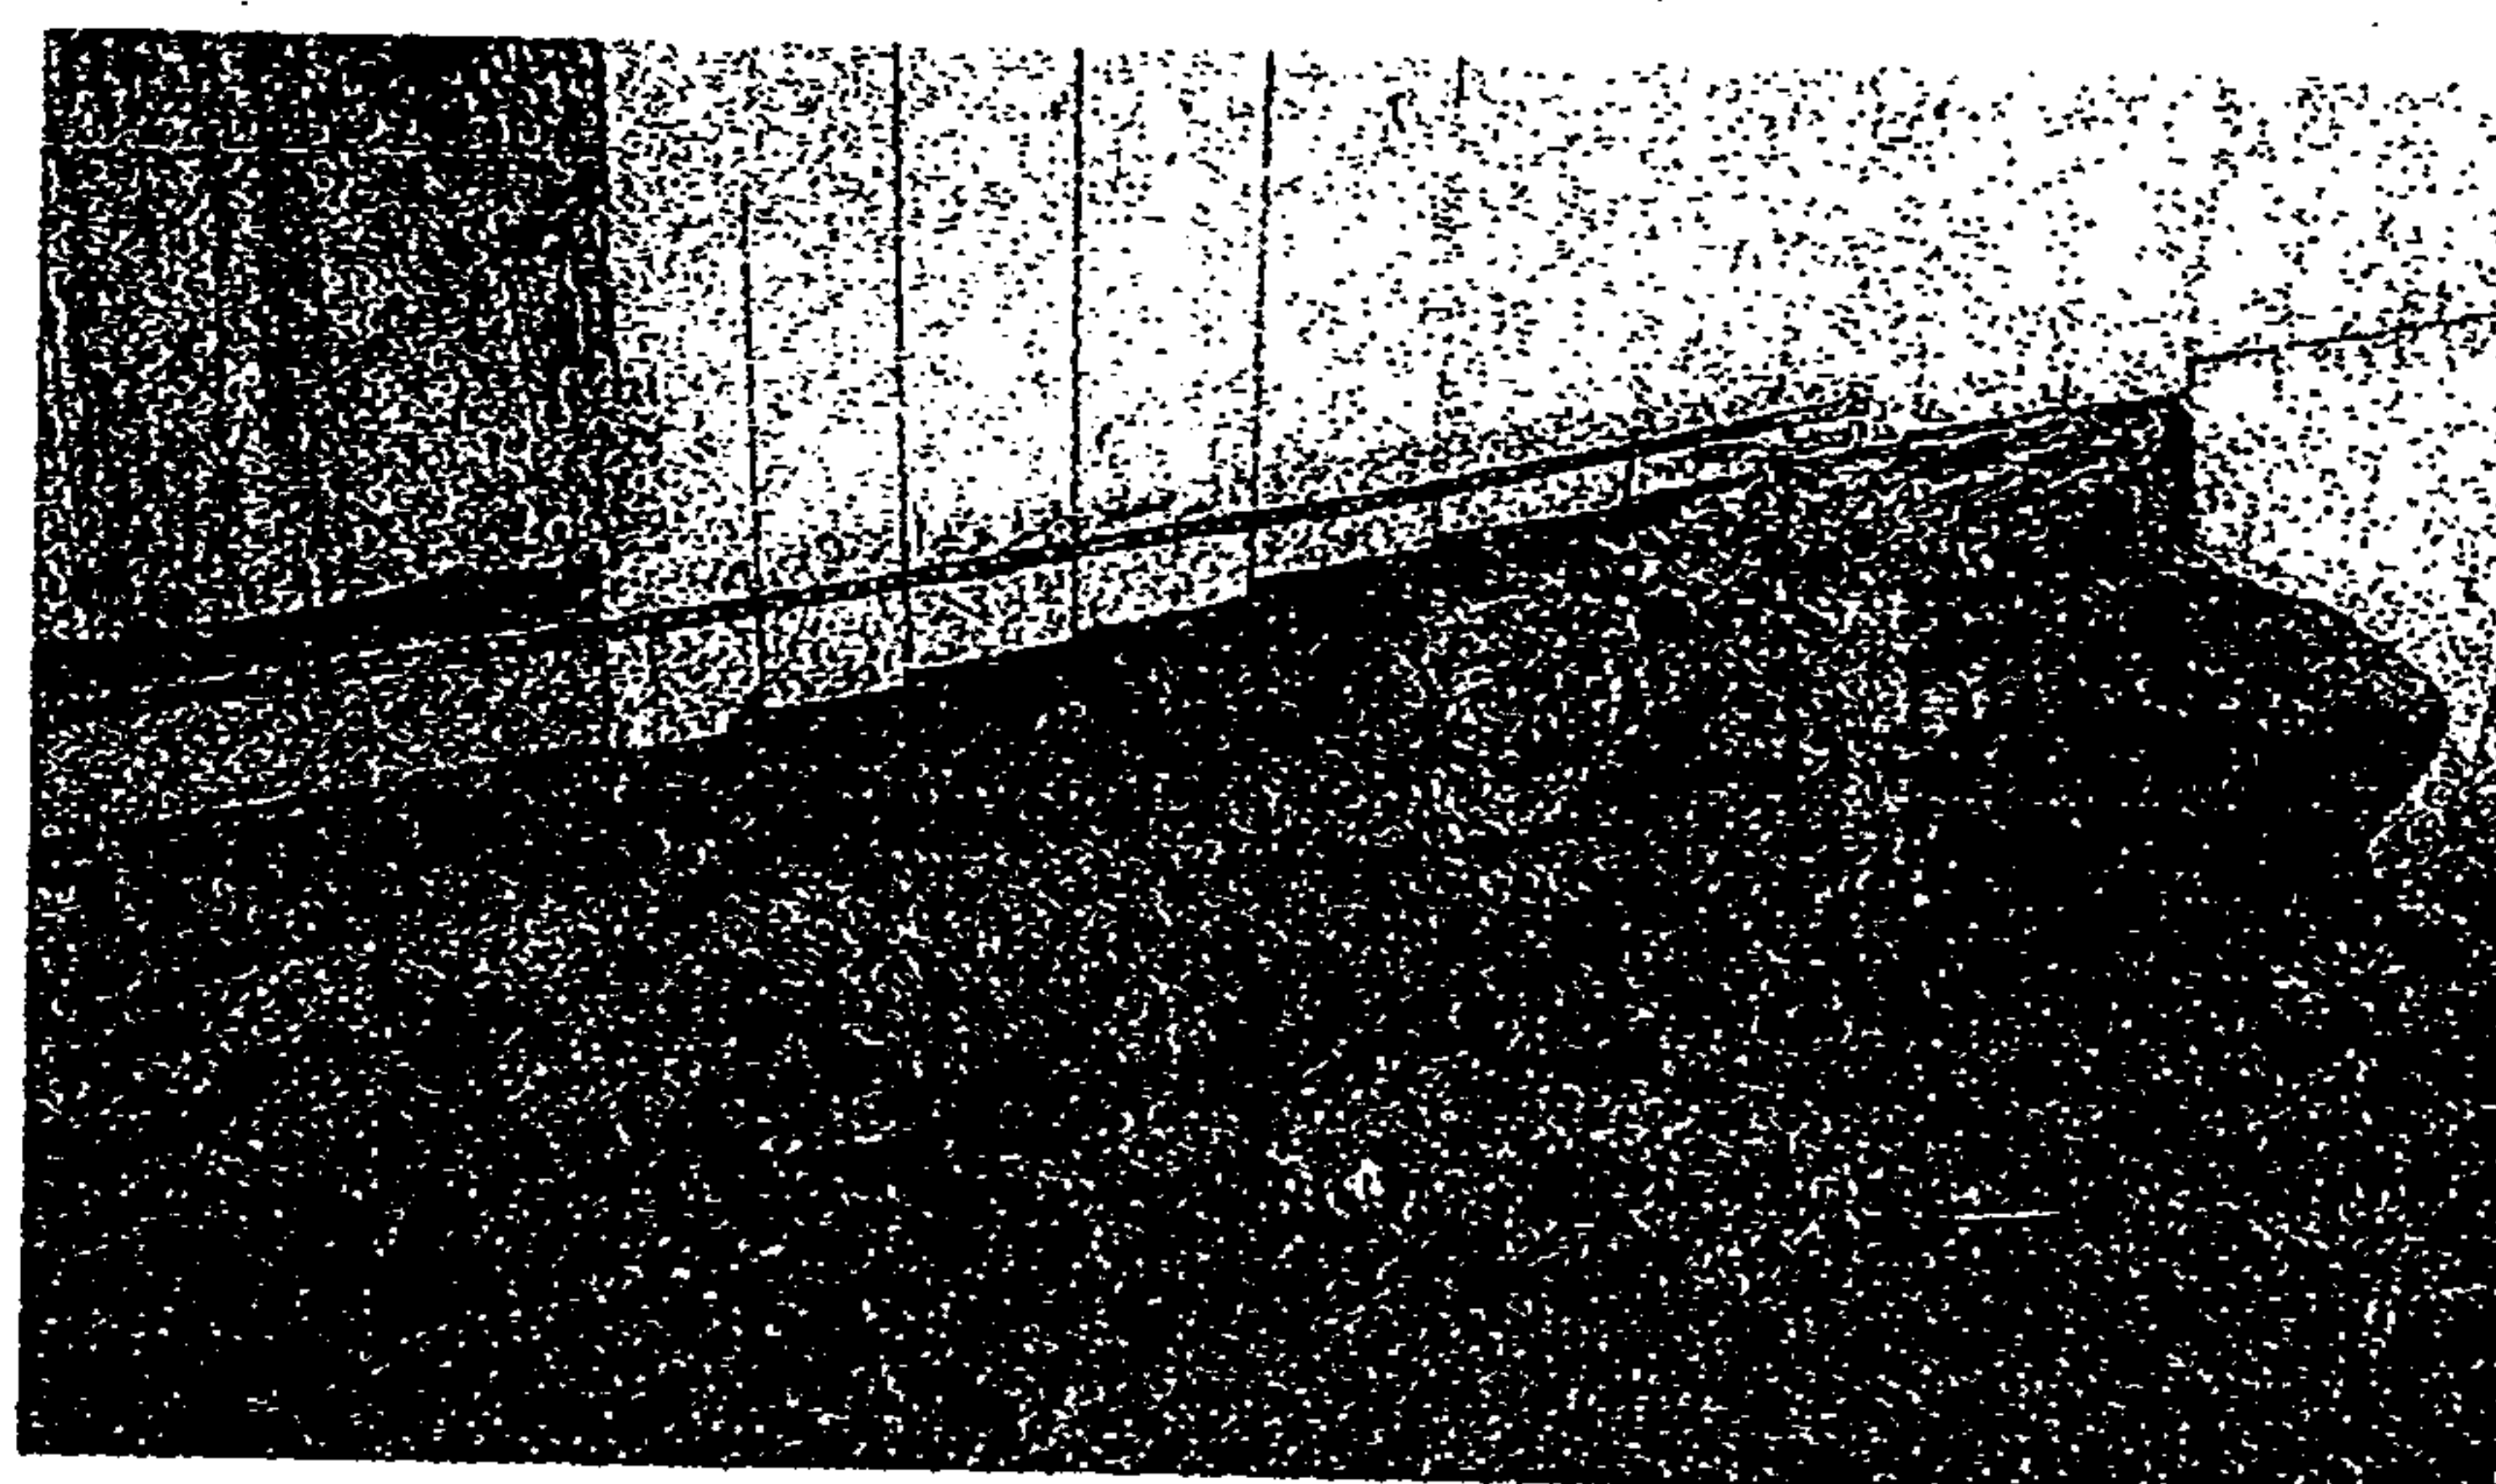
7. The pole barn structure at the rear of the building is in very poor condition. The loose laid stone foundation has suffered significant deterioration and is crumbling away. The wood sills at the top of the foundation walls have also experienced significant rot due to water exposure, as has the First Floor Framing.

Crumbling Barn Foundation

- a. The barn has very limited structural integrity, and no occupied use of this building should be permitted. It is our recommendation that the barn be demolished as soon as possible.

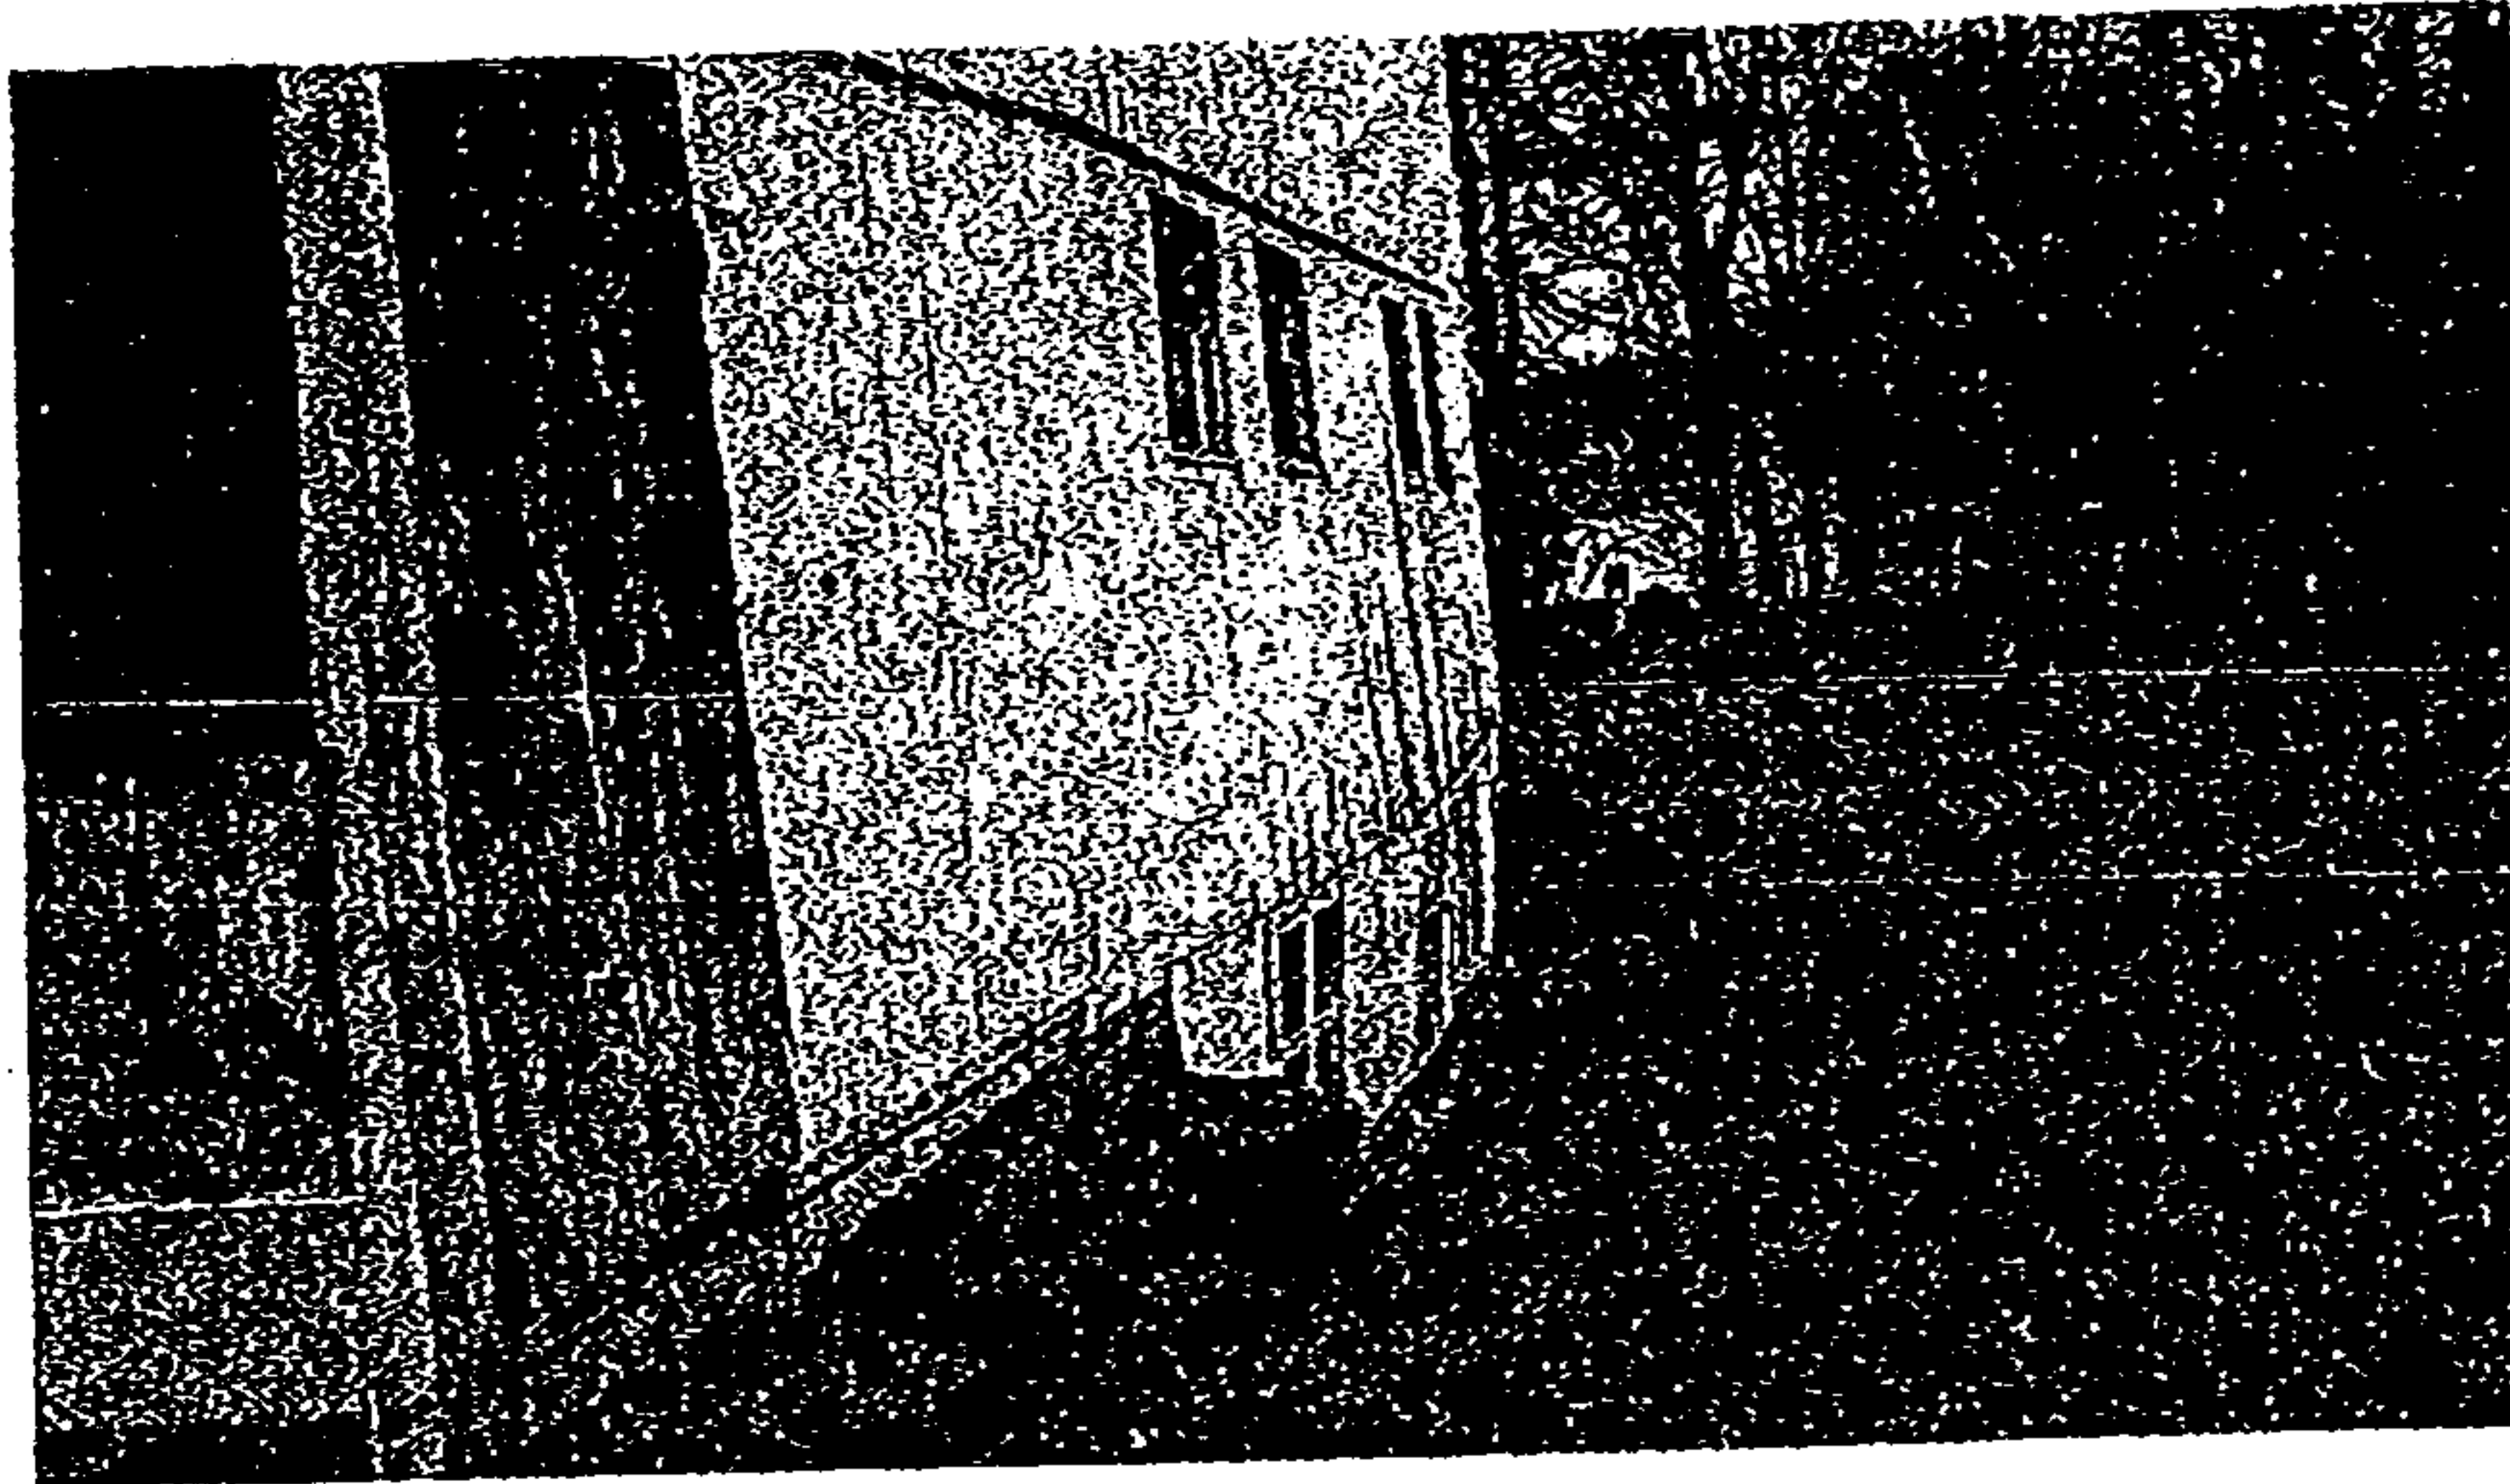
Barn Wall Deformation

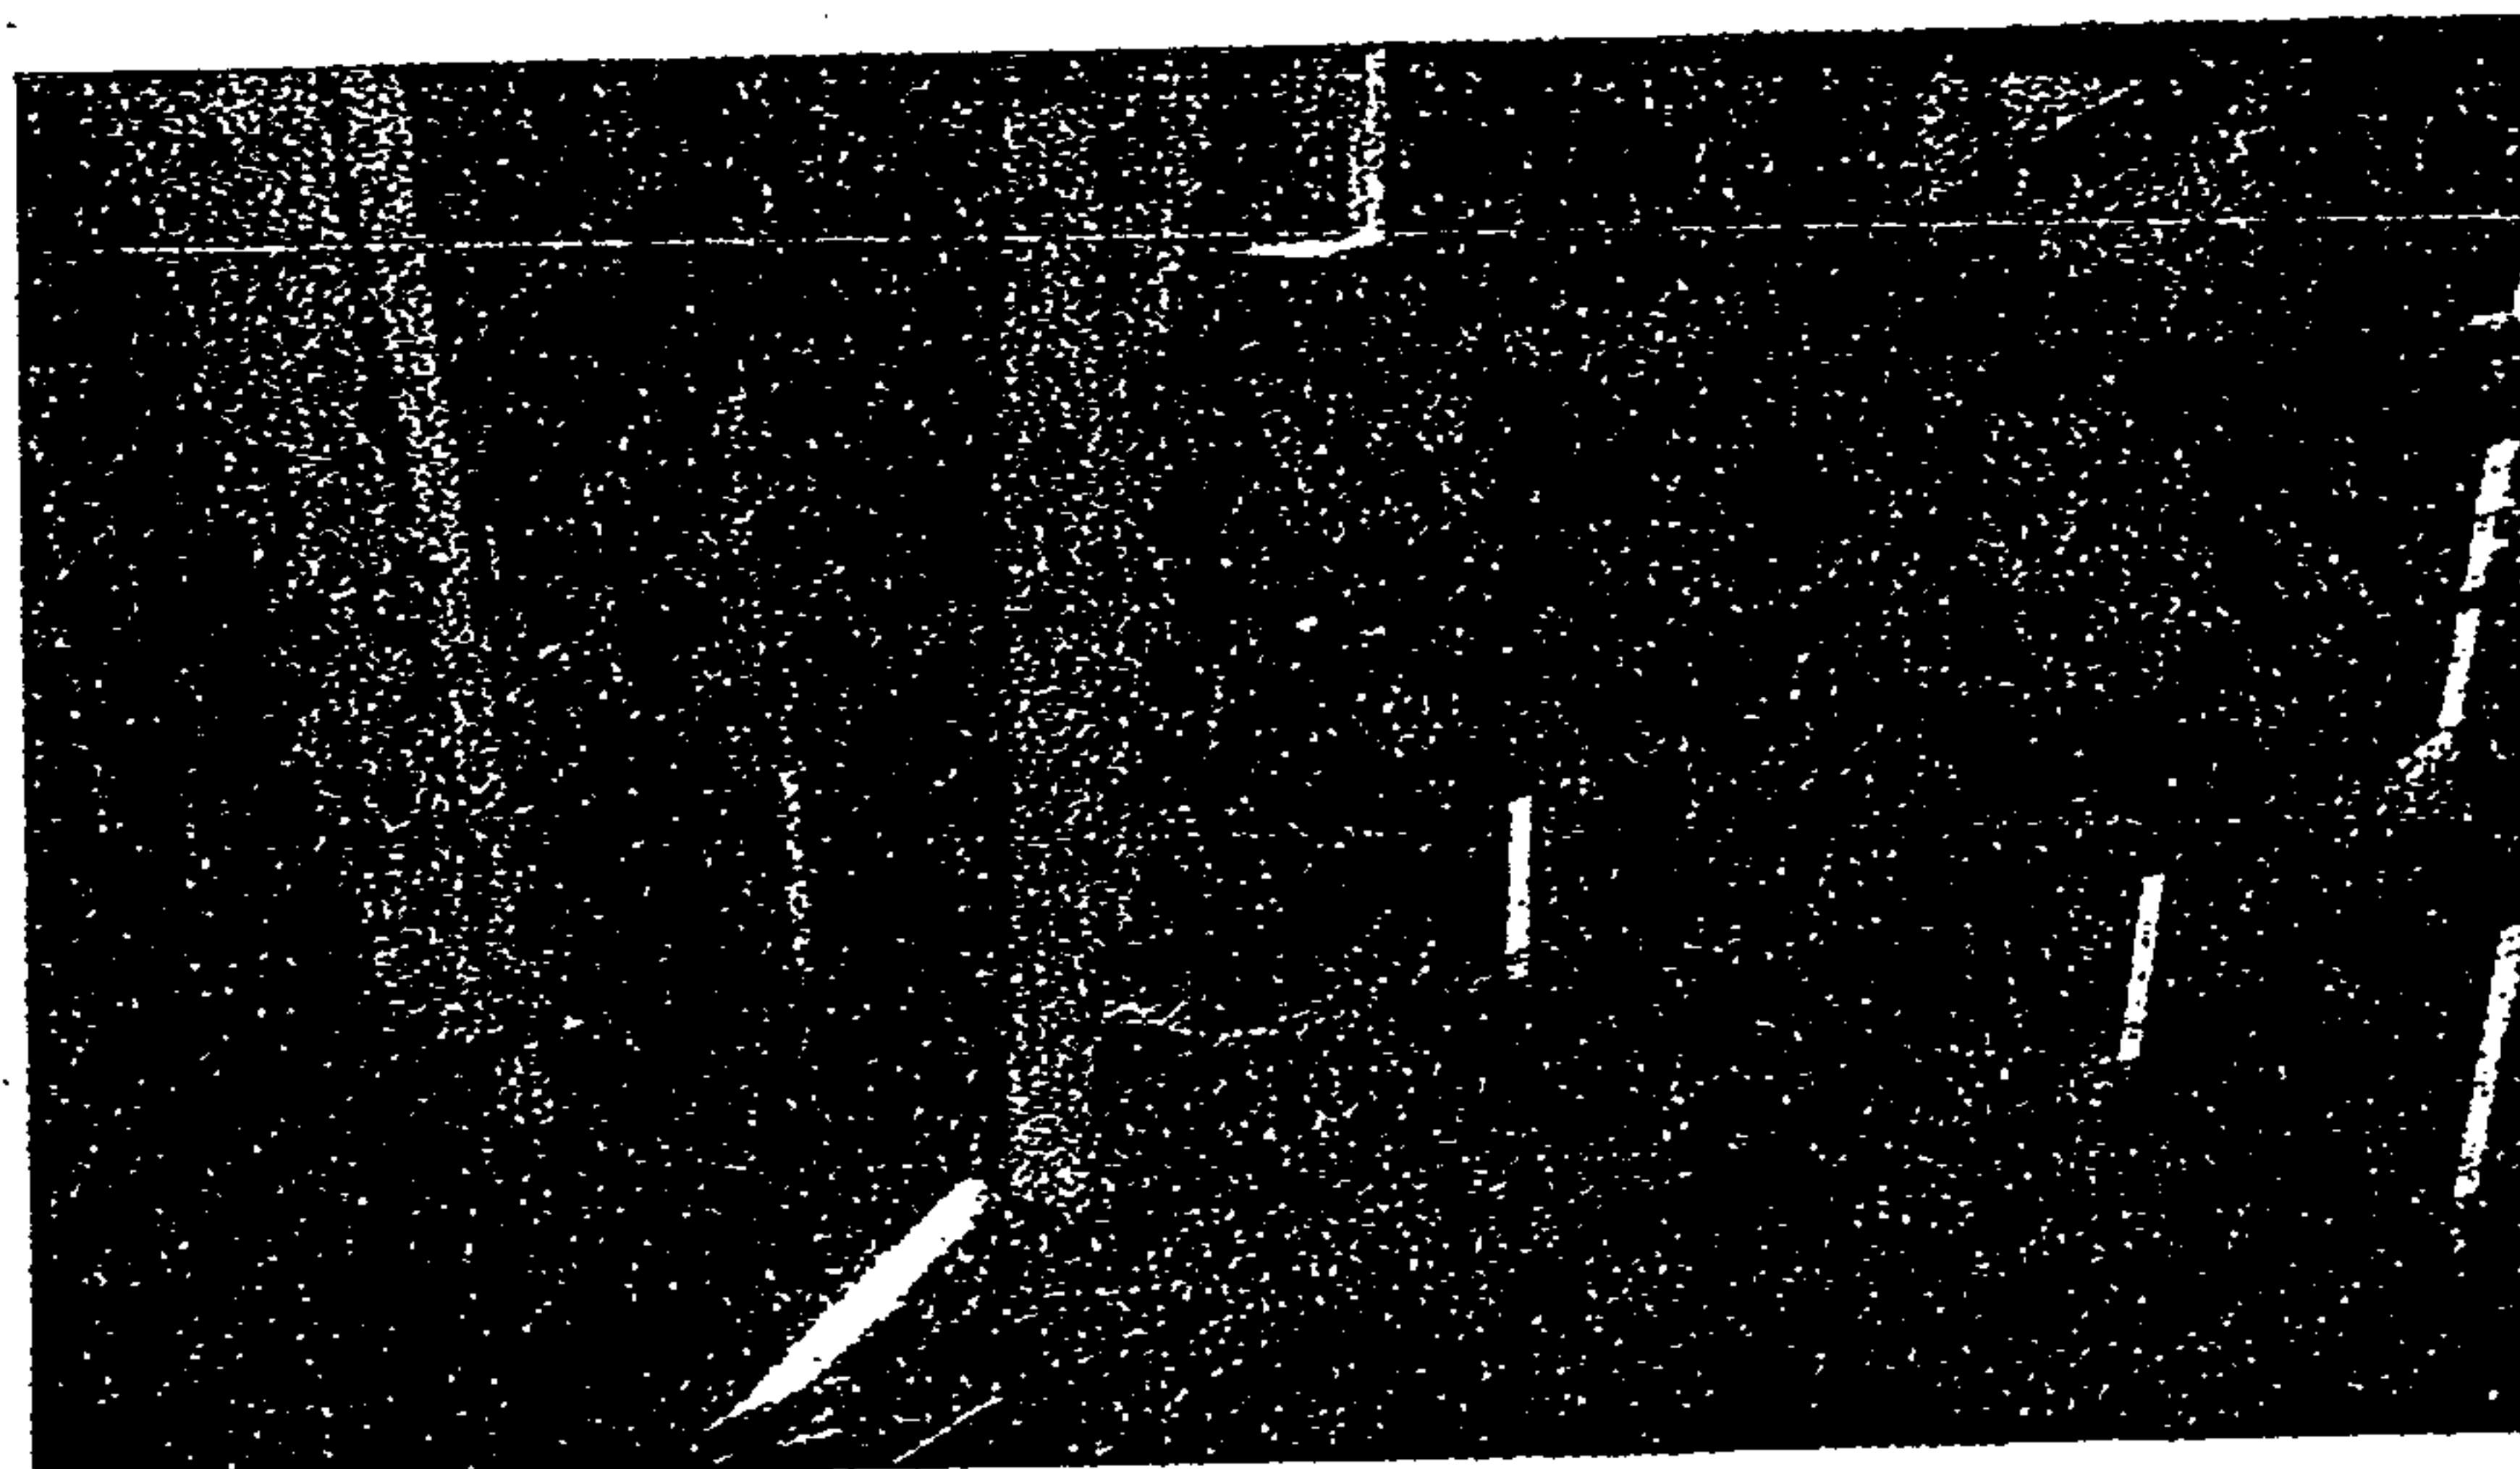
Deteriorated Barn Sills and Sheathing
