# Town of Brimfield, Massachusetts

## Town Building Assessment Study

## Capital Master Plan

February 24, 2014

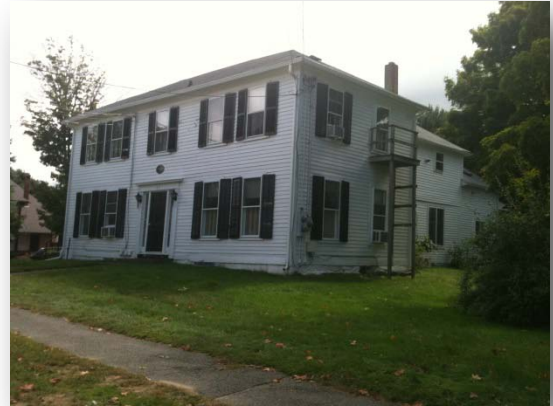
- Gable roof framing over the link structure is performing satisfactorily and nearly meets current snow load requirements for Brimfield. However, there are potential snow drift areas adjacent to the Barn and the original house (photo right). Review and reinforcing of these areas is recommended, in conjunction with future renovations to the building. In the interim, maintenance personnel should clear drifted snow, should it accumulate during the winter months.

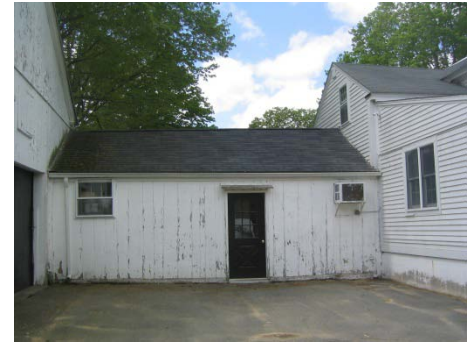
- The condition of the exterior walls in the original house could not be determined; however, the northeast corner of the structure is not plumb. The corner walls tilt inwards to the south and to the west. Further review is recommended, in conjunction with future renovations to the building.

- The handicap ramp on the east side of the original house (photos right) has deteriorated significantly; likely due to moisture and de-icing salts. Repair or replacement is required.

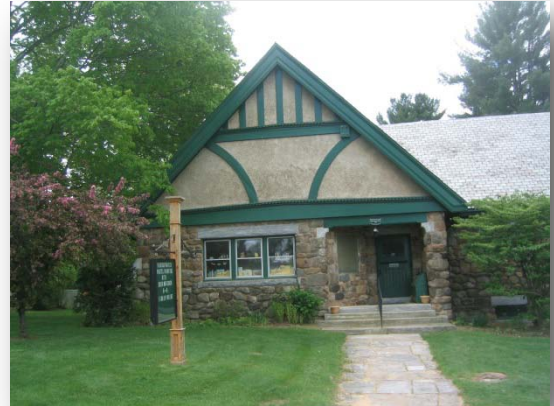
Structural conditions at the Danielson-Lincoln Memorial Library (building exterior) were observed during a brief visit to the site on May 13, 2013. Generally speaking, the wood-framed structure appears to be performing satisfactorily; there is no evidence of structural distress that would indicate significantly overstressed, deteriorated or failed structural members. Foundations appear to be performing adequately; there are no signs of significant, total or differential settlements.

- The condition of the exterior stone walls appears to be generally satisfactory. Masonry joints appear to be in satisfactory condition as well.
- The capacity of the First Floor framing was not determined; however, the use of the building has not changed since the original construction, and there are no reports of any structurally related issues.
- The capacity of the roof framing was not determined; however, roof framing appears to be functioning as originally intended.

- There are damaged/missing areas of roof trim at a number of locations around the building. Downspouts are disconnected and some downspouts do not properly direct water away from the foundation walls. If not repaired, these conditions will continue to allow moisture into the building and allow water to build up behind foundation walls.

- The exterior stucco finish at the back, gable end wall of the Sherman Memorial Room is failing and has bowed outwards. This condition should be repaired to prohibit moisture from entering the walls.
- Wood framing may typically be protected (to a degree) by the ceiling construction; however, elsewhere it is unprotected. There are no sprinklers. Fire rating requirements should be reviewed in conjunction with future renovations to the facility.
