ARE YOU A VICTIM?

Crumbling BASEMENTS

Connecticut Coalition Against Crumbling Basements

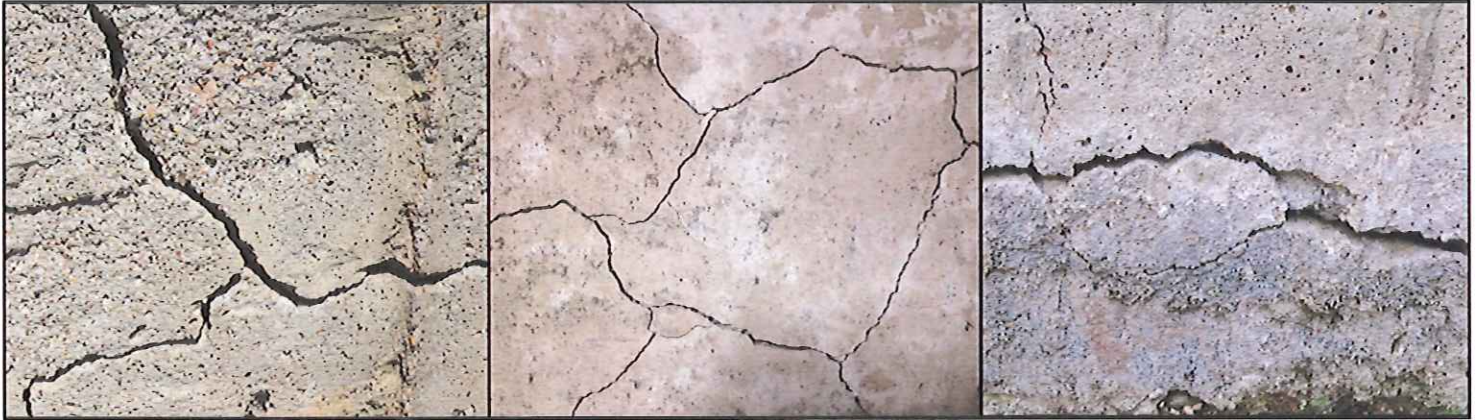
Was your home/addition built in the 1980s or later?
Do your basement walls look like this?

If so, you may be affected by concrete containing pyrrhotite.

Pyrrhotite is an **iron sulfide mineral**. It has been found in a quarry in northeastern Connecticut that provided **building aggregate** for construction projects in the region. Over time, pyrrhotite that is **exposed to oxygen and water reacts and causes swelling and cracking**. As a structure continues to deteriorate, it often **becomes unsound**. No repairs have been found to solve this problem. **The only repair is to replace.**

The cracking is **not** normal settling or shrinkage

Cracks typically take 15 to 20 years to appear

Cracks may be horizontal, on a 45° angle, or in a spider pattern

You may notice white powder in and around the cracks

Brown stains or drips may appear that resemble rust
